**FACILITY ASSESSMENT REPORT
MAPLE VALLEY SCHOOL DISTRICT
ORISKA SCHOOL
APRIL 2016**

ICON
ARCHITECTURAL GROUP

Karges-Faulconbridge, Inc.
Engineers

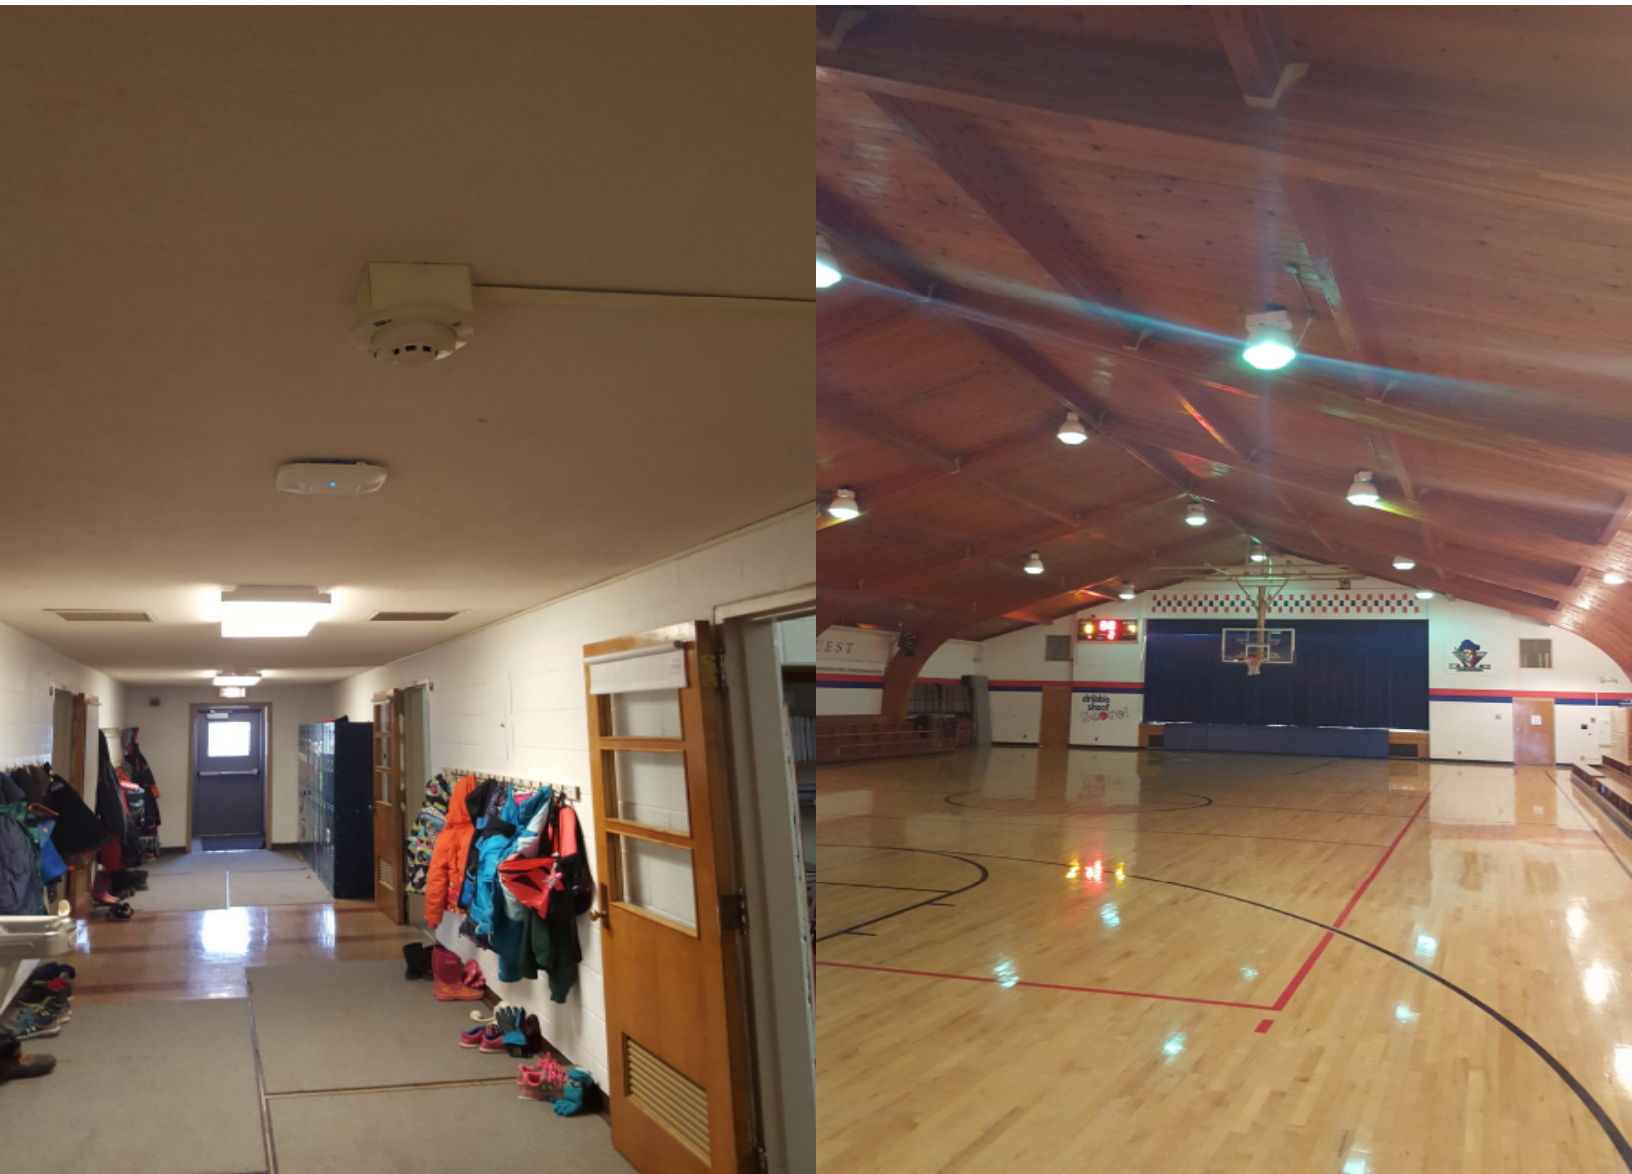
2012 IBC: SECTION 903.2.3 GROUP E

- An automatic sprinkler system shall be provided for Group E occupancies as follows:
 - Throughout all Group E fire areas greater than 12,000 square feet in area.

Corrective Action: Provide automatic sprinkler system throughout existing building. Provide smoke detection in gymnasium. Replace light fixtures with energy efficient fixtures.

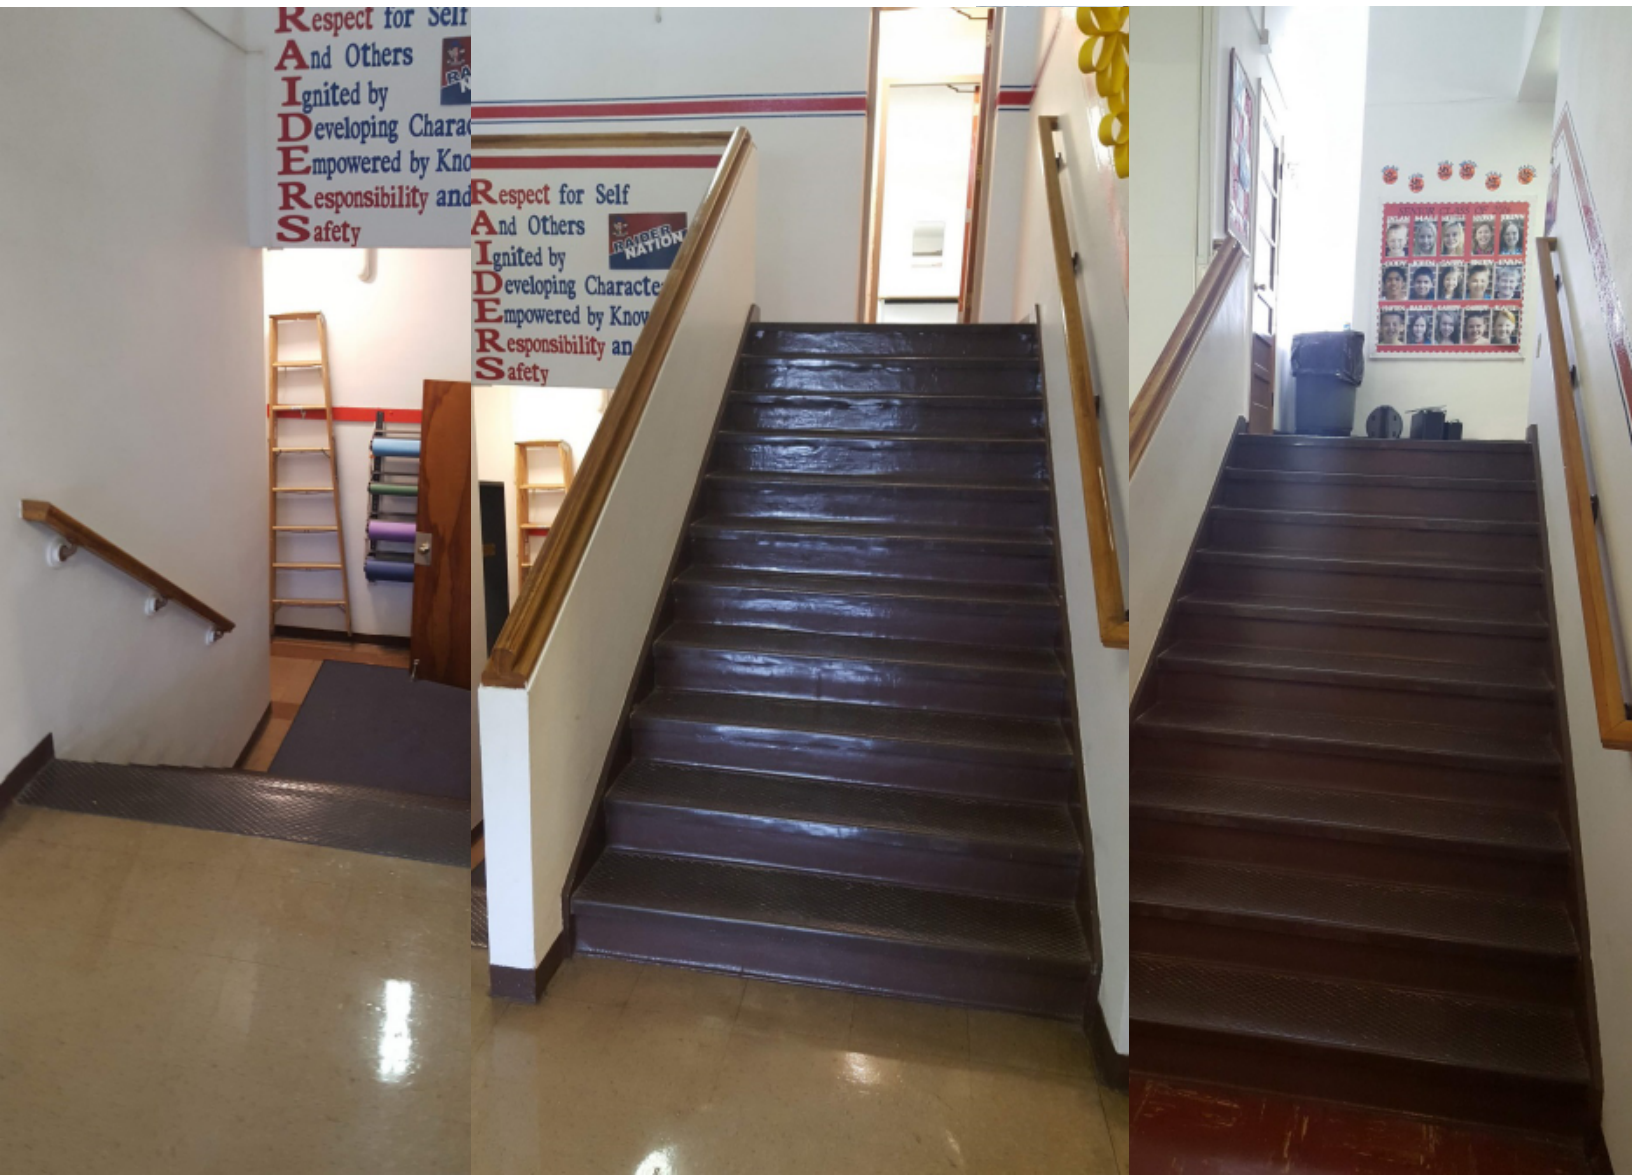
2012 IBC: SECTION 1022 INTERIOR EXIT STAIRWAYS AND RAMPS

- Interior exit stairways and ramps shall lead directly to the exterior of the building or shall be extended to the exterior of the building with an exit passageway.

Corrective Action: Provide two interior exit stairways for egress from second floor. Both of these stairways will be required to be rated enclosures with no other purpose than as a means of egress leading directly to the exterior. Install elevator for access to second floor.

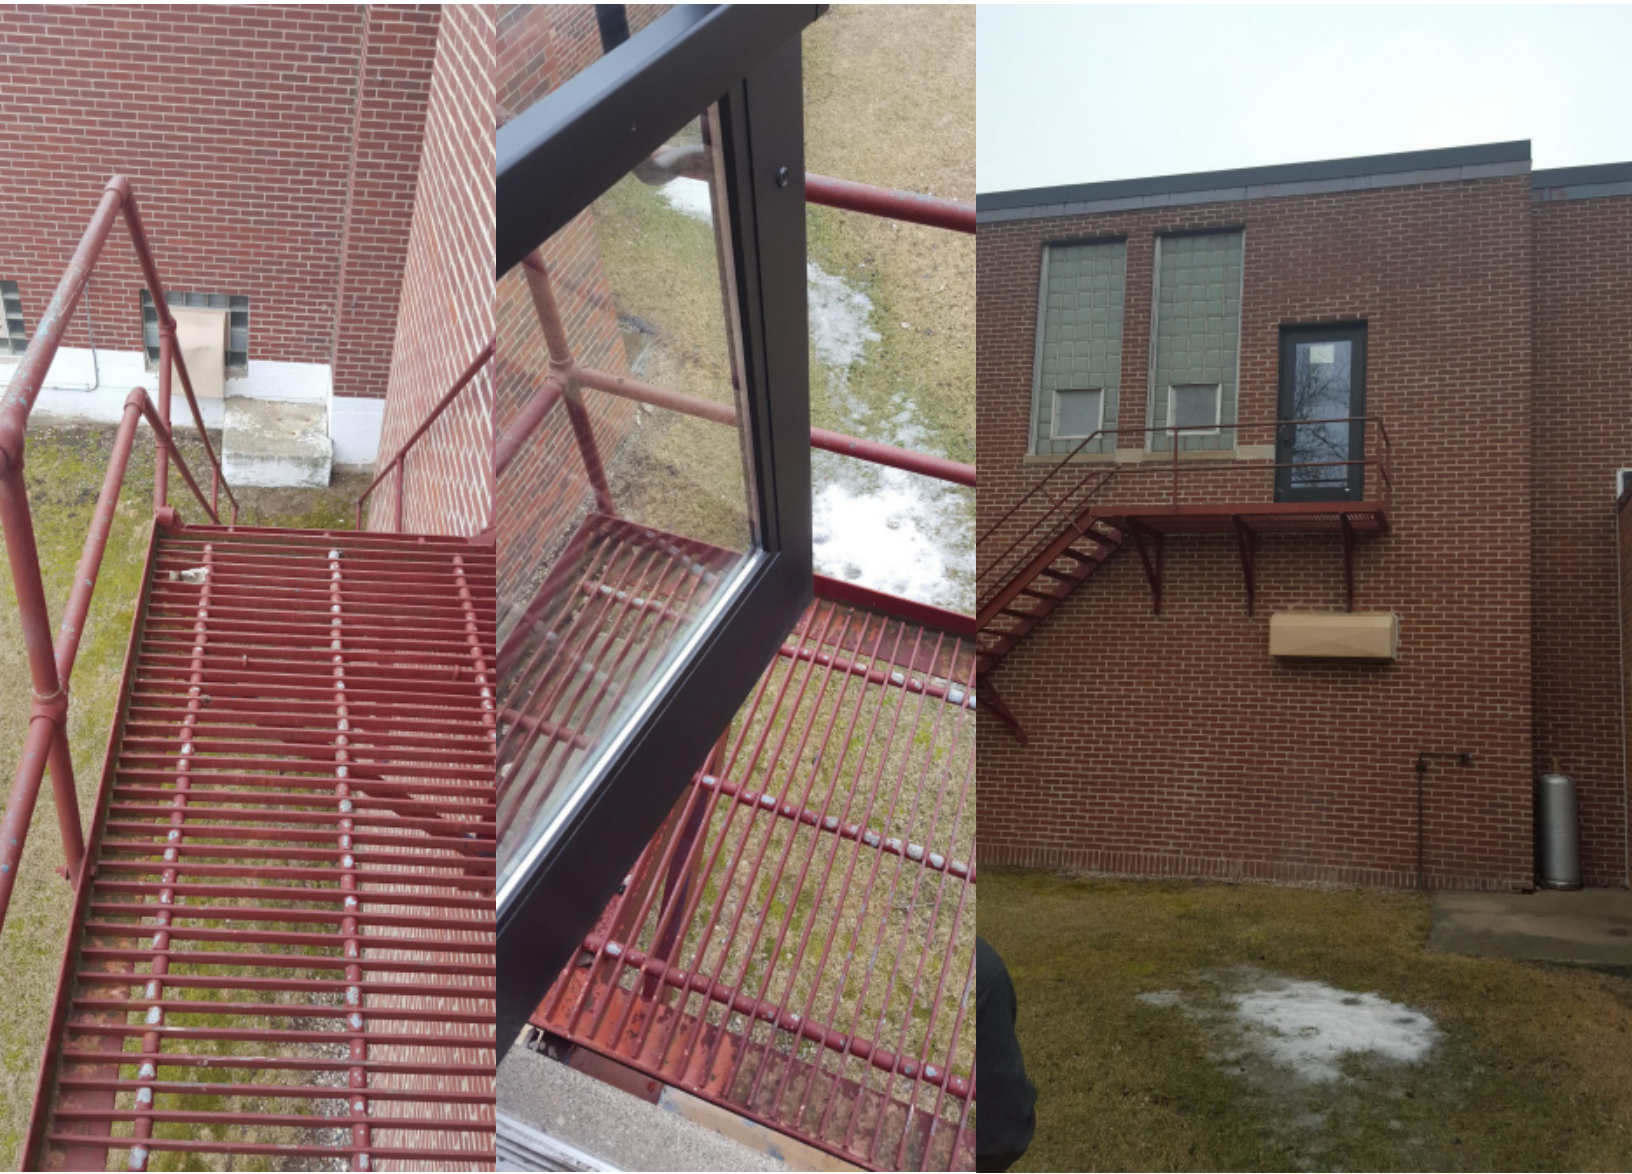
2012 IBC: SECTION 1022 INTERIOR EXIT STAIRWAYS AND RAMPS

- Interior exit stairways and ramps shall lead directly to the exterior of the building or shall be extended to the exterior of the building with an exit passageway.

Corrective Action: Emergency escape does not meet requirements of being a rated enclosure with no other purpose than as a means of egress leading directly to the exterior. To be considered a second means of egress a rated interior exit stairway must be constructed that connects directly to the corridor, not through an intervening space as it currently does.

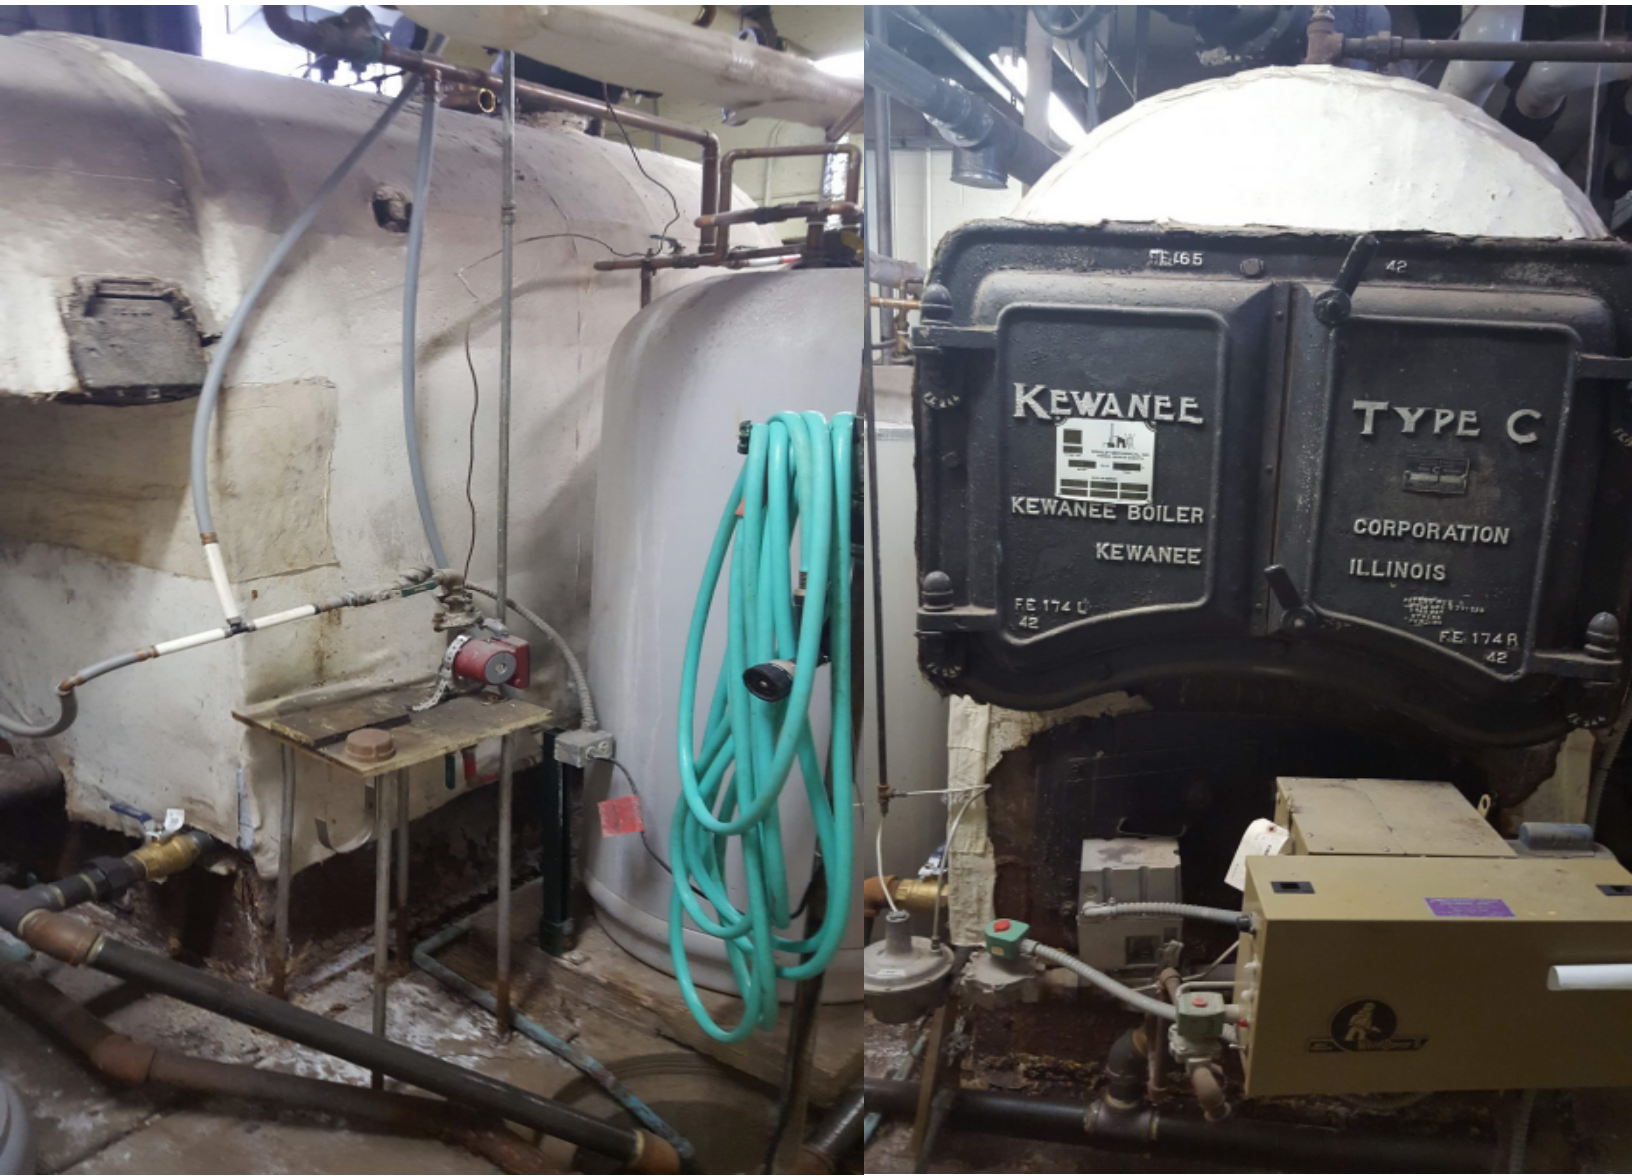
The building is heated with steam generated by two steam boilers, one Kewanee natural gas boiler and one Coates Cam Industries electric boiler. Kewanee boiler is original to building was recently repaired in 2013. Kewanee went out of business in 2001. The gas boiler is beyond its useful life. The electric boiler was installed in 1980 and is approaching the end of its useful life. The condensate boiler feed system appears to be in good condition. Boiler room does not have emergency shutdowns properly located to meet current codes. Combustion air ventilation is under sized. Boiler piping and venting contains asbestos throughout facility and needs to be abated. Steam is distributed throughout the building for heating applications via tunnels. The existing steam traps are original to the building and need to be replaced. Given the age of the overall system, replacing the system would be recommended, including piping, valves, controls, and accessories.

Corrective Action: The building is heated with steam generated by two steam boilers, one Kewanee natural gas boiler and one Coates Cam Industries electric boiler. Kewanee boiler is original to building and was recently repaired in 2013. The gas boiler is beyond its useful life. The electric boiler was installed in 1980 and is approaching the end of its useful life. Boiler room does not have emergency shutdowns properly located to meet current codes. Combustion air ventilation is under sized. Steam is distributed throughout the building for heating applications via tunnels. The existing steam traps are original to the building and need to be replaced. Replacing the system would be recommended, including piping, valves, controls, and accessories.

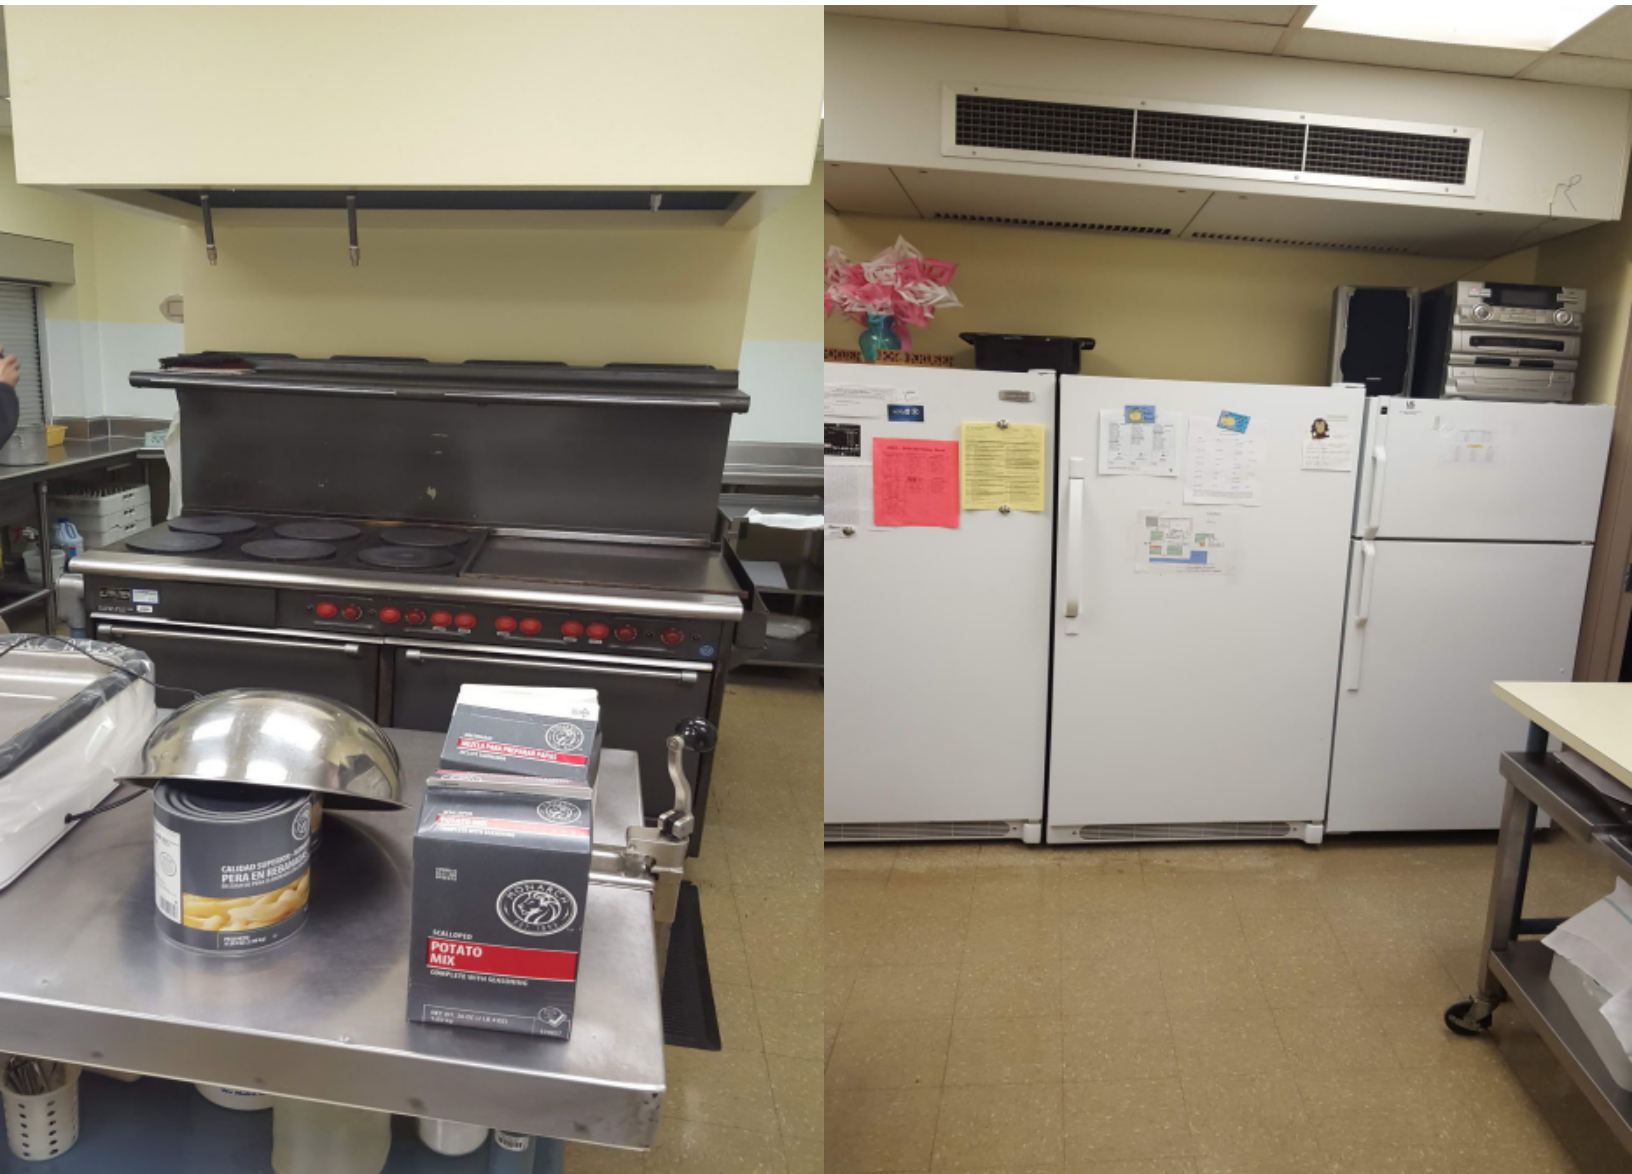
There is no ventilation into the building, with the exception of the gymnasium/stage and the kitchen. However, the kitchen ventilation appears to be non-operational and the gymnasium/stage units are beyond their useful life. New ventilation systems would be required throughout to meet current ventilation and energy codes.

Existing kitchen ventilation system does not meet current codes and would need to be replaced. Makeup air unit would need to be replaced. Dishwasher would require a new hood and makeup air system.

Corrective Action: There is no ventilation into the building, with the exception of the gymnasium/stage and the kitchen. However, the kitchen ventilation appears to be non-operational and the gymnasium/stage units are beyond their useful life. New ventilation systems would be required throughout to meet current ventilation and energy codes. Existing kitchen ventilation system does not meet current codes and would need to be replaced. Makeup air unit would need to be replaced. Dishwasher would require a new hood and makeup air system.

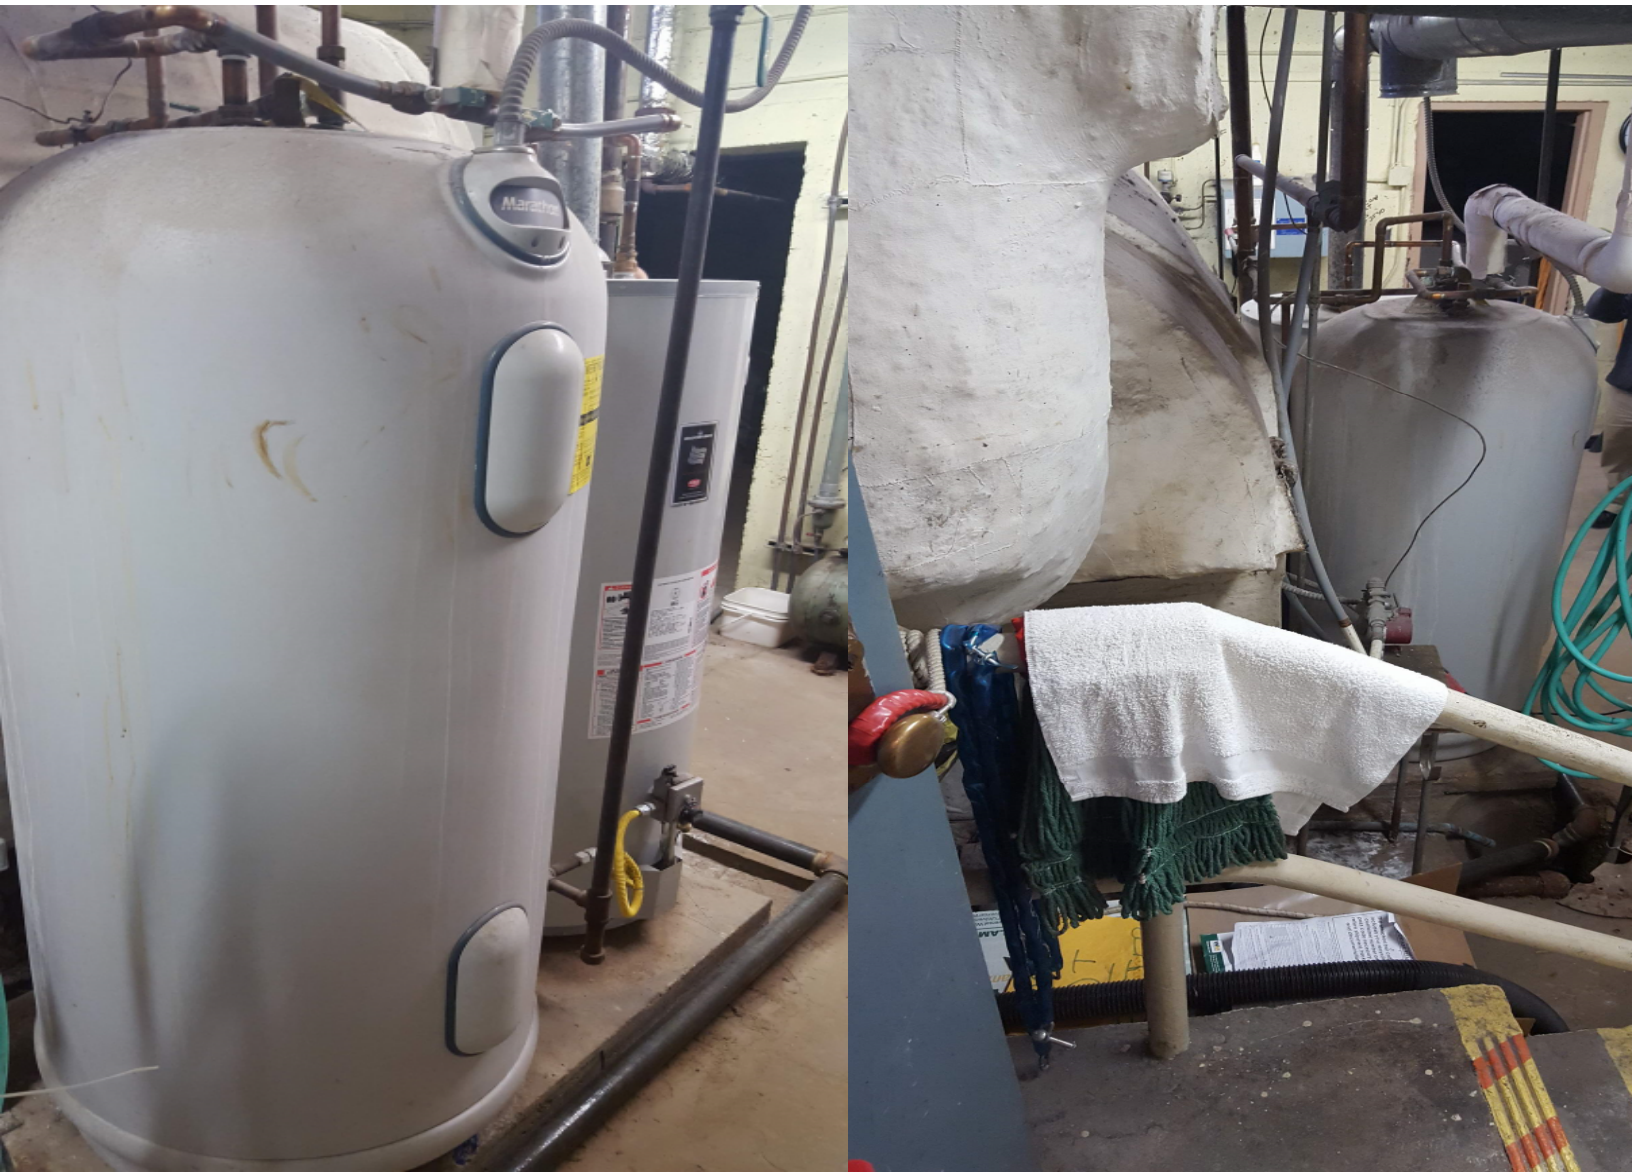
There are both an electric water heater and a gas water heater. Both water heaters are approaching the end of their useful life. The electric water heater is the newer of the two and was installed in 2001.

Corrective Action: There are both an electric water heater and a gas water heater. Both water heaters are approaching the end of their useful life. The electric water heater is the newer of the two and was installed in 2001.

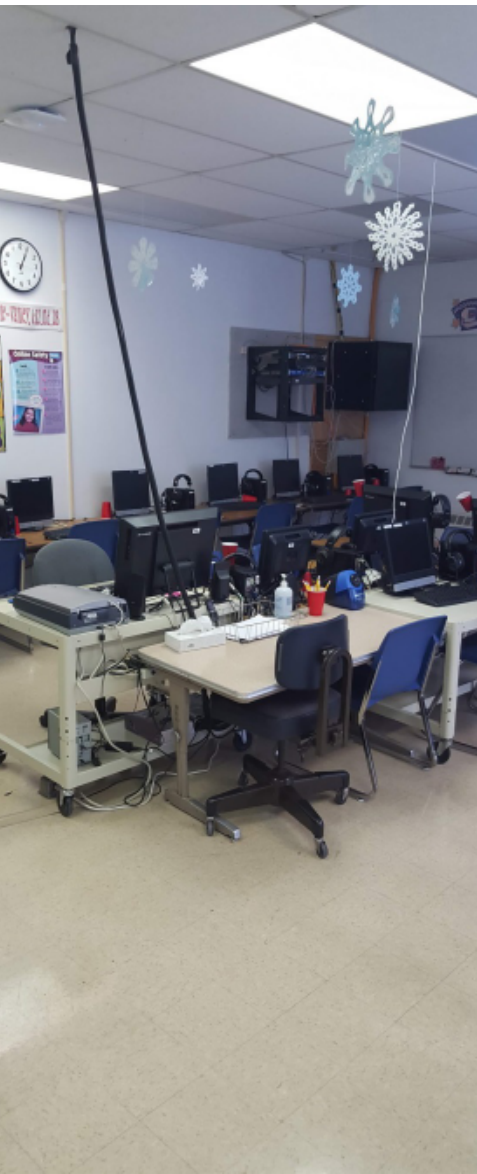
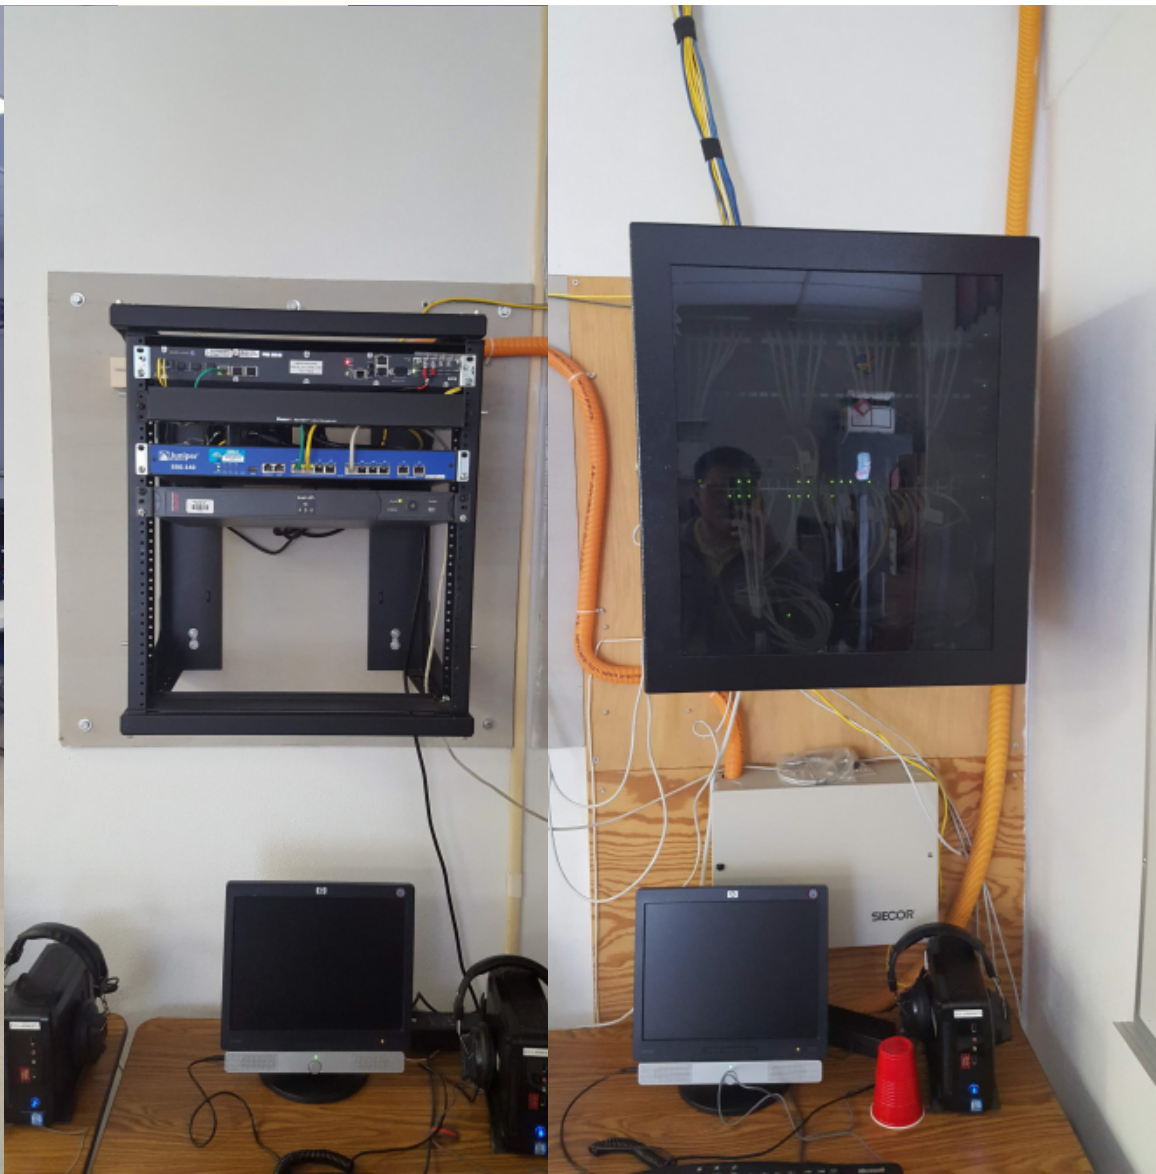
Data room / computer classroom is not properly temperature controlled. Auxiliary cooling unit would need to be added.

Corrective Action: Data room / computer classroom is not properly temperature controlled. Auxiliary cooling unit would need to be added.

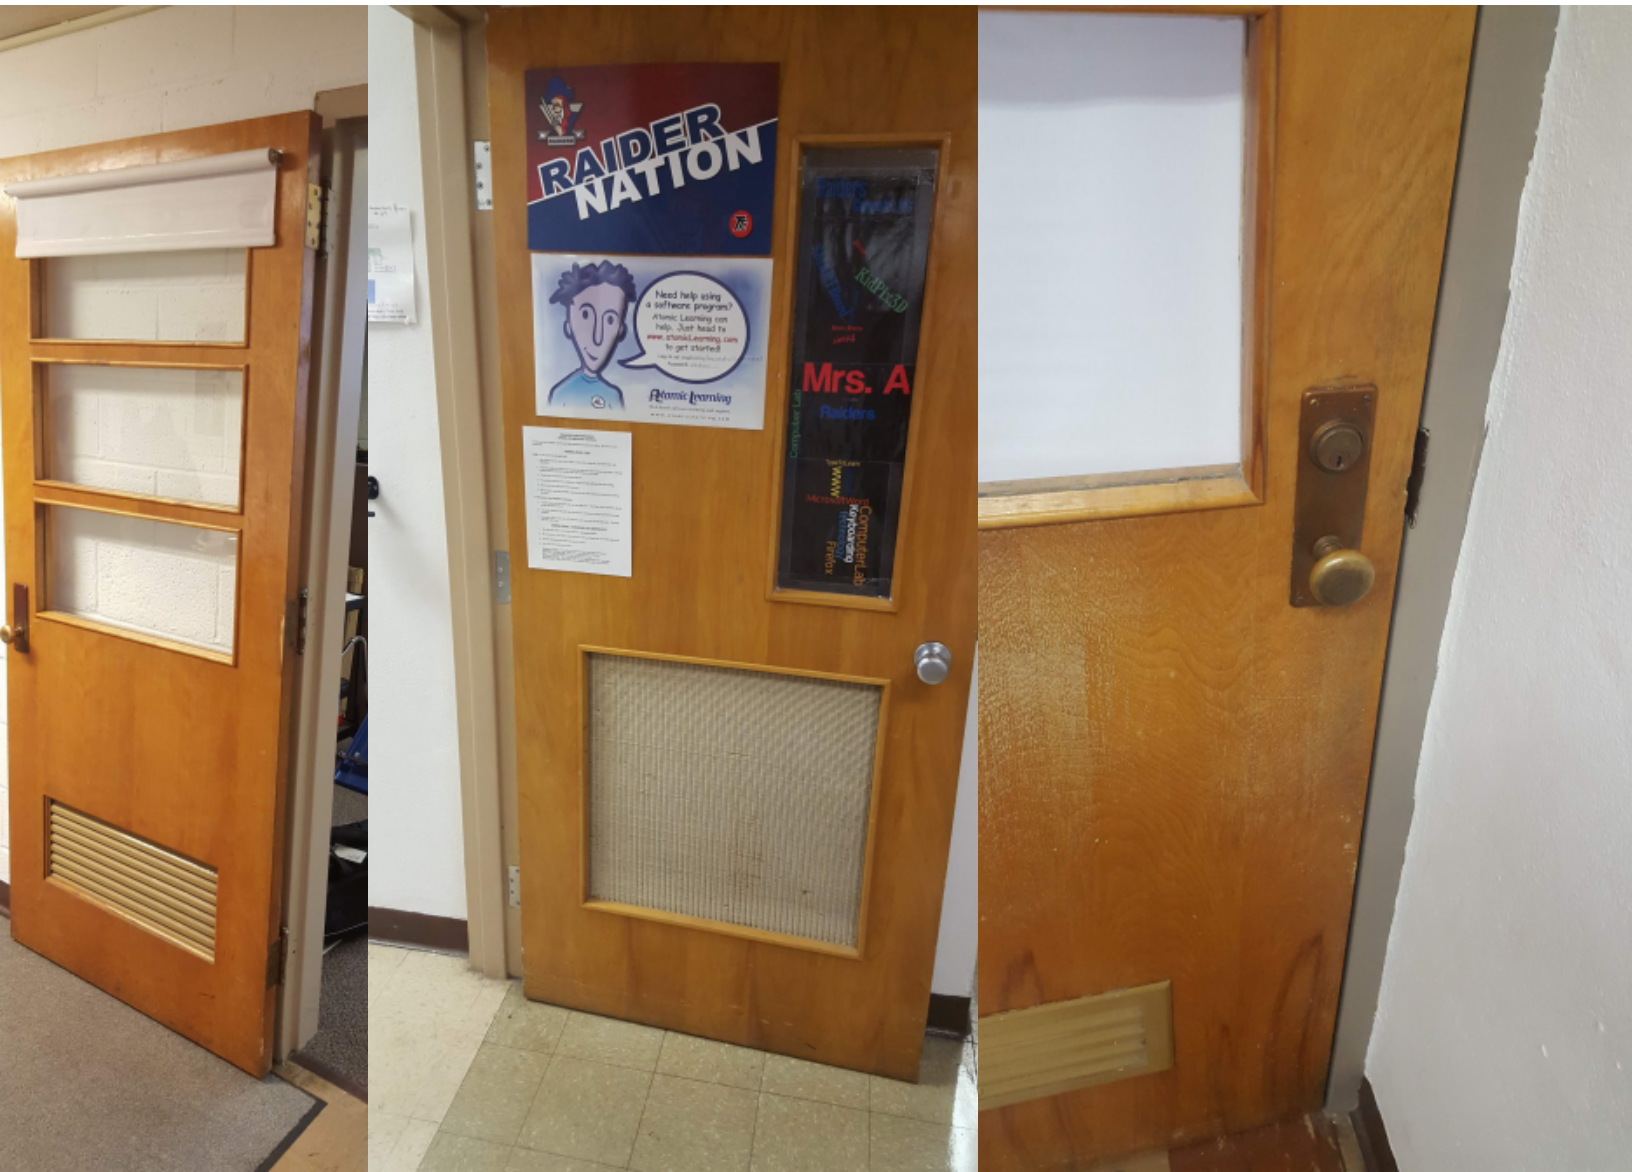
2012 IBC: SECTION 716.5.3 DOOR ASSEMBLIES IN CORRIDORS AND SMOKE BARRIERS

- Fire door assemblies required to have a minimum fire protection rating of 20 minutes where located in corridor walls or smoke barrier walls

2012 IBC: SECTION 1008.1.9.1 HARDWARE

- Door handles, pulls, latches, locks and other operating devices on doors required to be accessible by Chapter 11 shall not require tight grasping, tight pinching or twisting of the wrist to operate.

Corrective Action: Replace all doors and frames in corridors with properly fire-rated doors and frames including fire-rated glass and louvers. Replace all door hardware with accessible hardware.

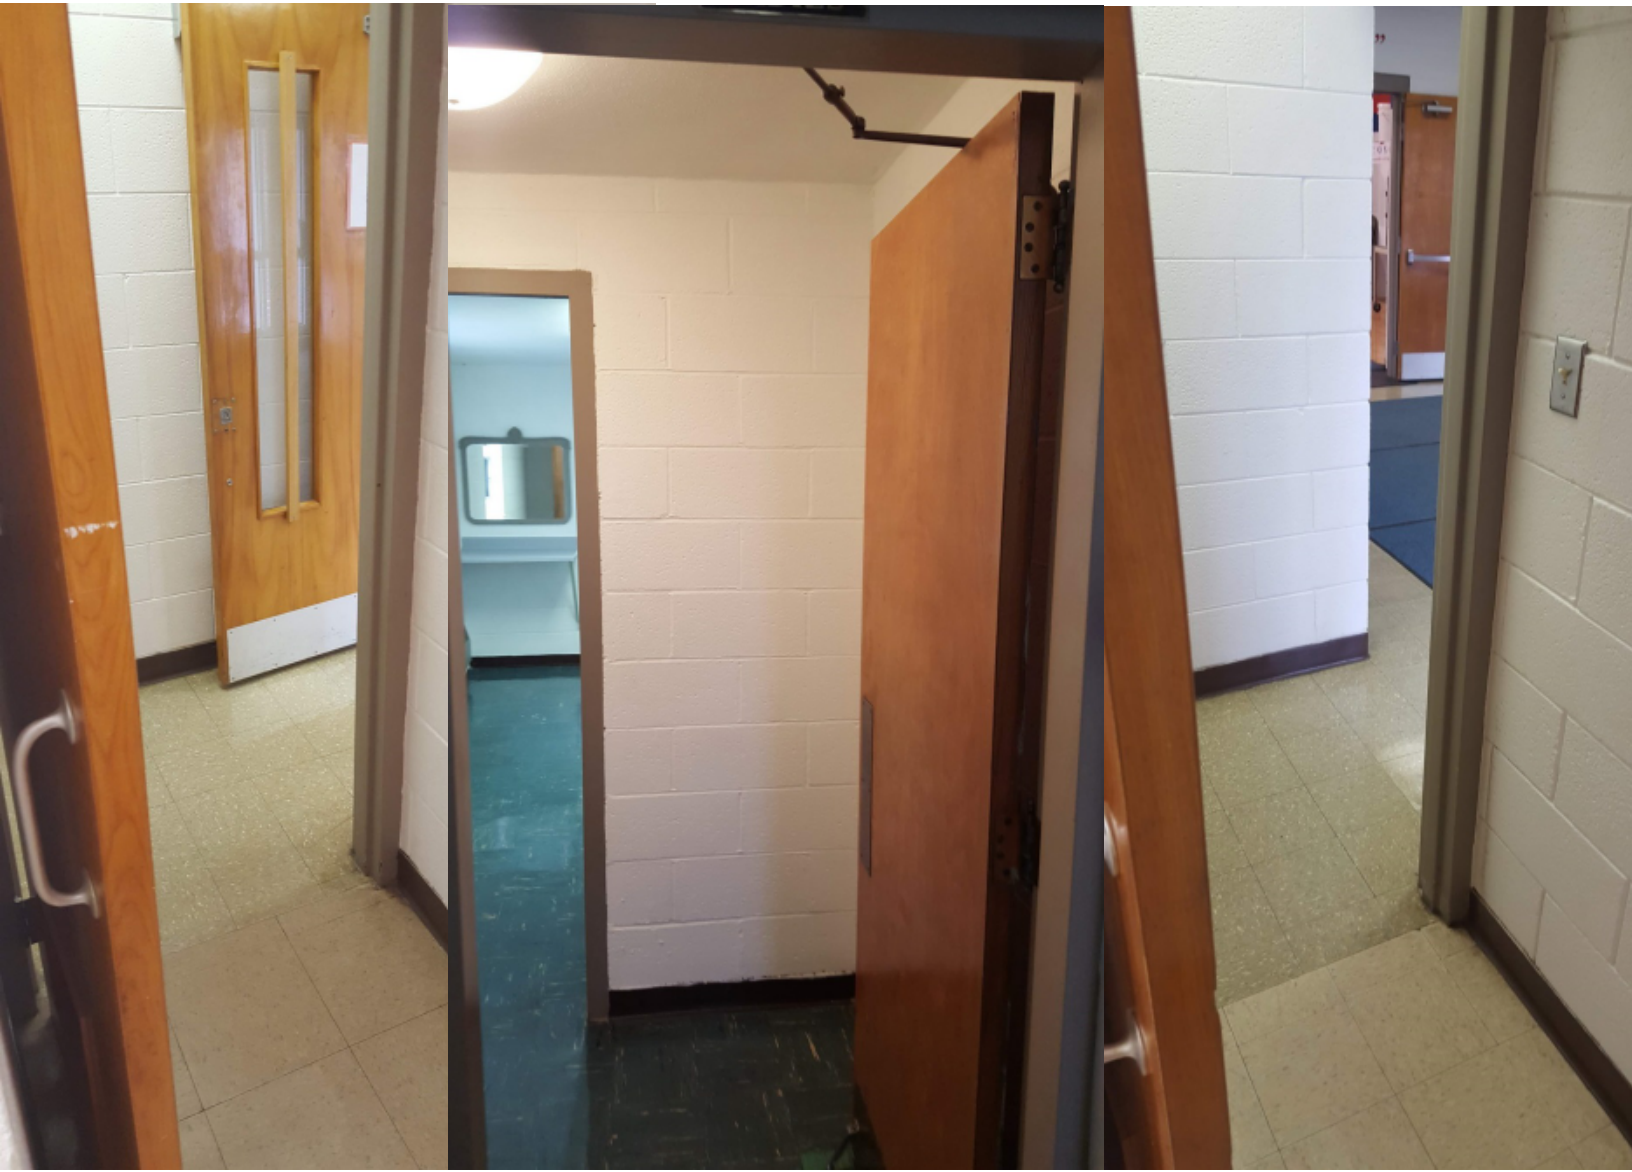
2012 IBC: SECTION 1109.2 TOILET AND BATHING FACILITIES

- Each toilet room and bathing room shall be accessible.

Corrective Action: Bathrooms will be required to be renovated to provide clearances to make restrooms accessible.

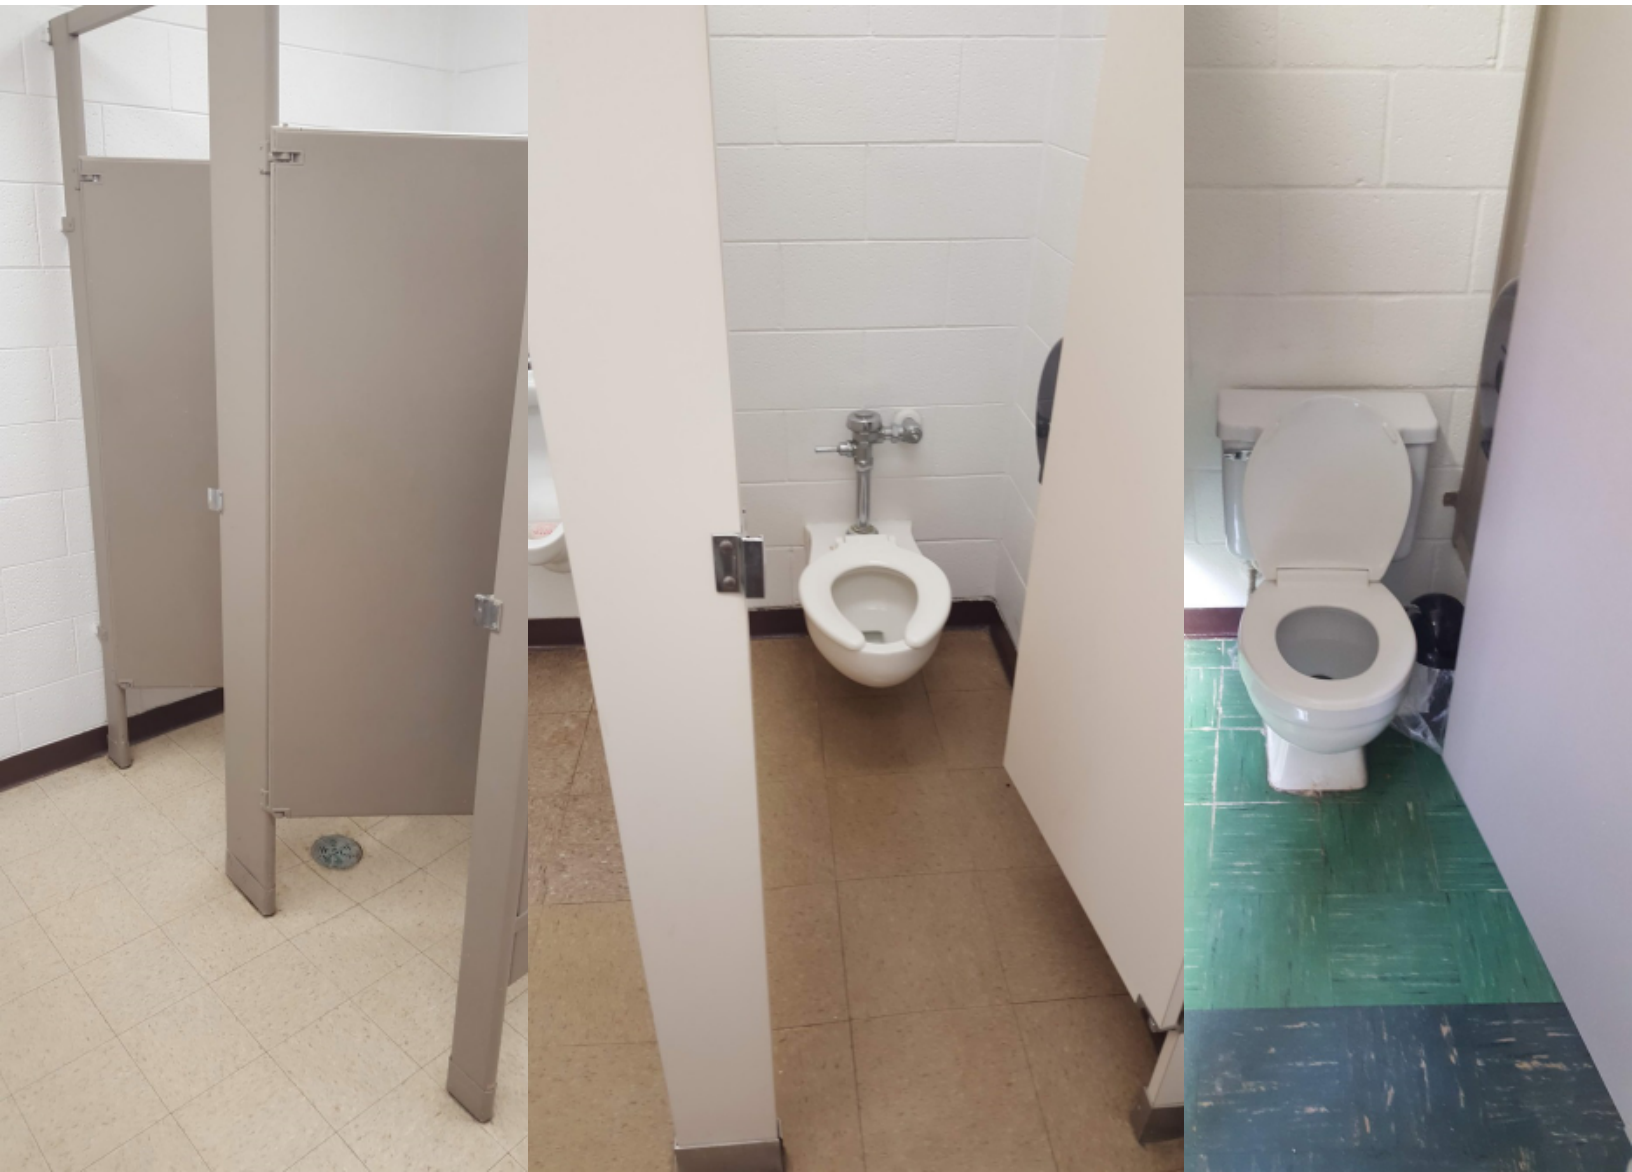
2012 IBC: SECTION 1109.2 TOILET AND BATHING FACILITIES

- Each toilet room and bathing room shall be accessible. At least one of each type of fixture, element, control or dispenser in each accessible toilet room and bathing room shall be accessible.

Corrective Action: Provide accessible toilet compartments and add fixtures to meet required plumbing counts.

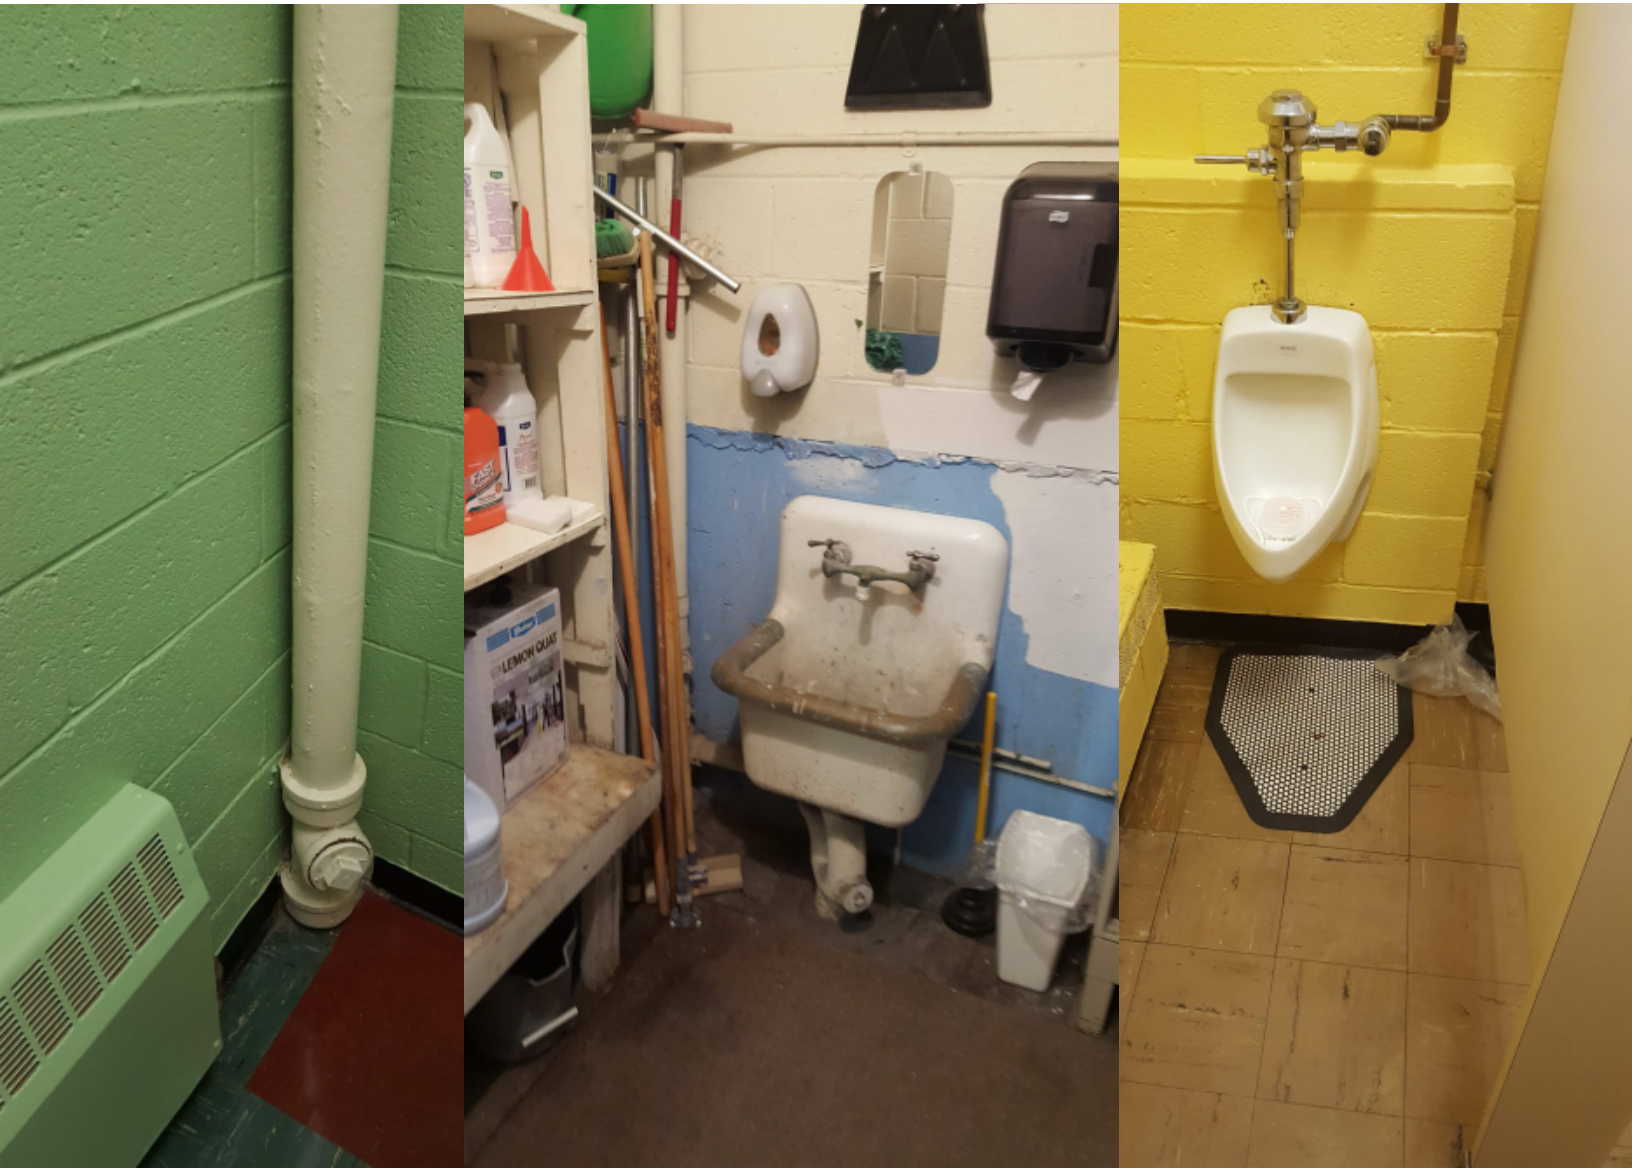
Sanitary system appears to be original cast iron piping and is beyond its useful life. All sanitary piping should be replaced throughout.

Corrective Action: Sanitary system appears to be original cast iron piping and is beyond its useful life. All sanitary piping should be replaced throughout. Given the age of the building, the domestic water piping should be replaced throughout.
