**FACILITY ASSESSMENT REPORT
MAPLE VALLEY SCHOOL DISTRICT
ORISKA SCHOOL
APRIL 2016**

ICON
ARCHITECTURAL GROUP

Karges-Faulconbridge, Inc.
Engineers

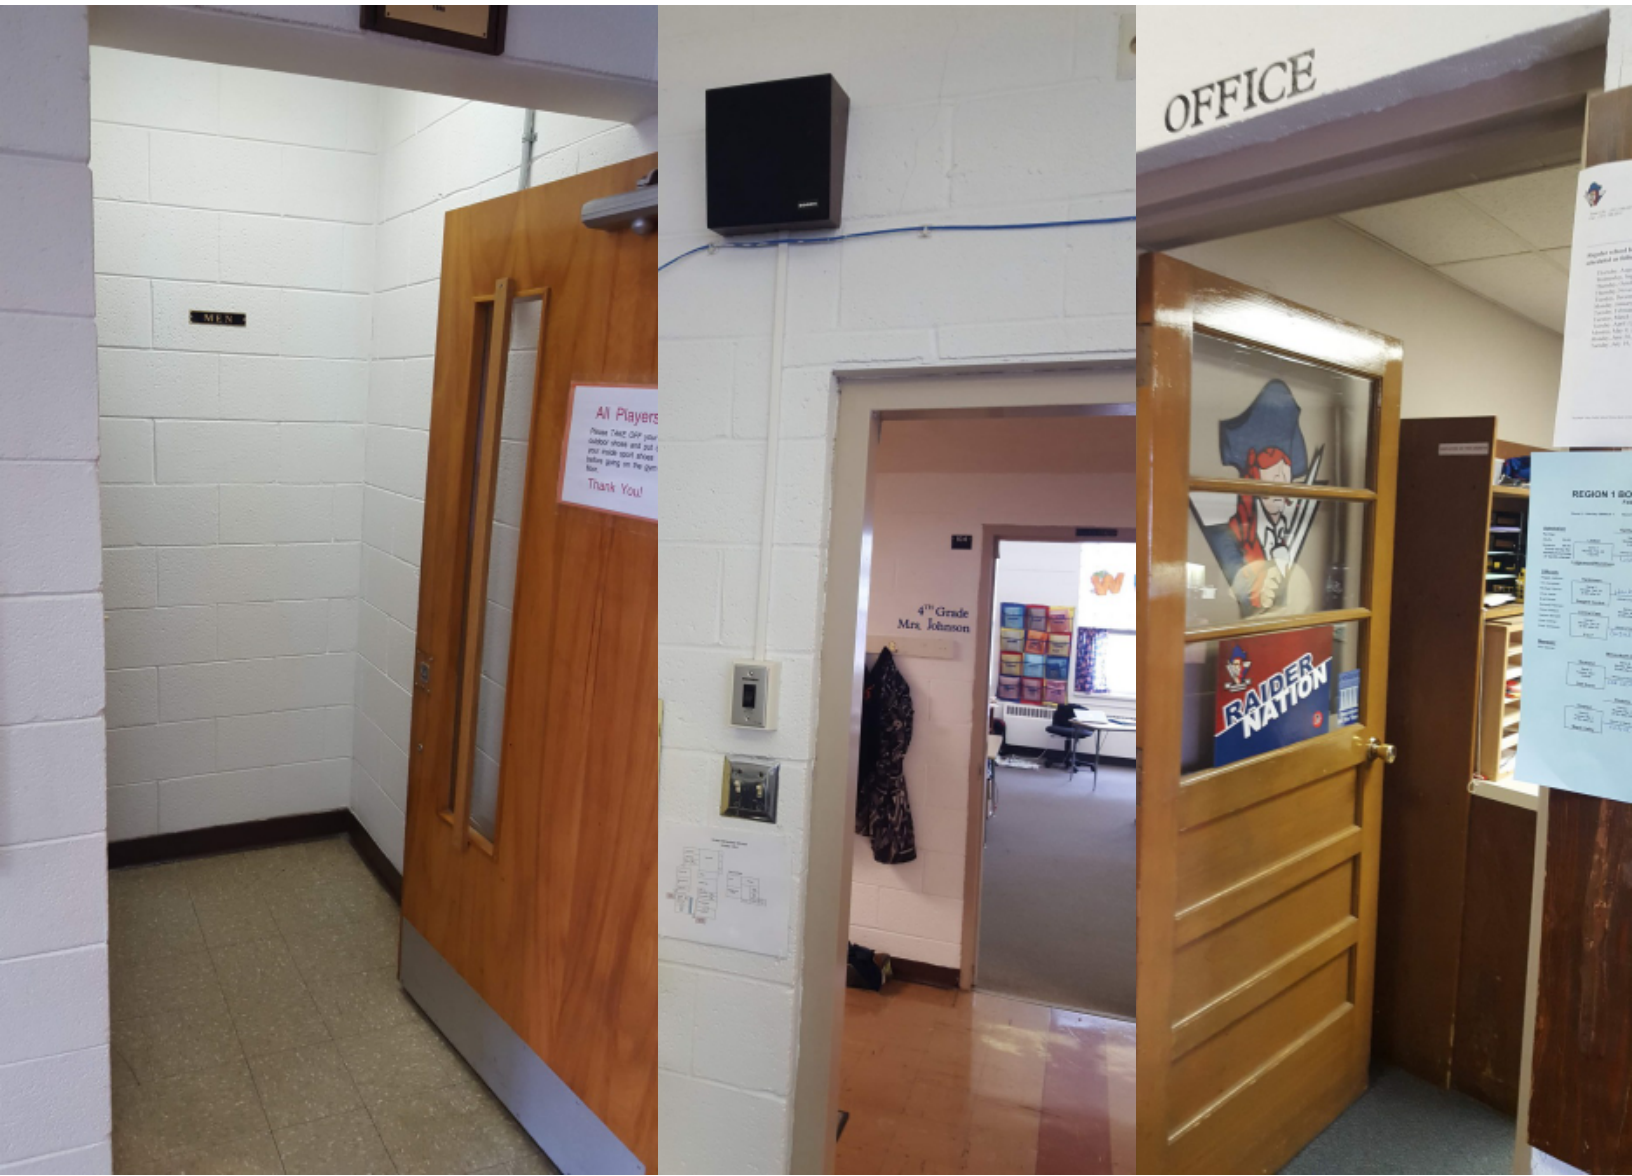
2012 IBC: SECTION 1110.1 Signs

- Required accessible elements shall be identified by the International Symbol of Accessibility.

Corrective Action: Provide signage indicating accessibility provisions at all entrances, and rooms required to be accessible.

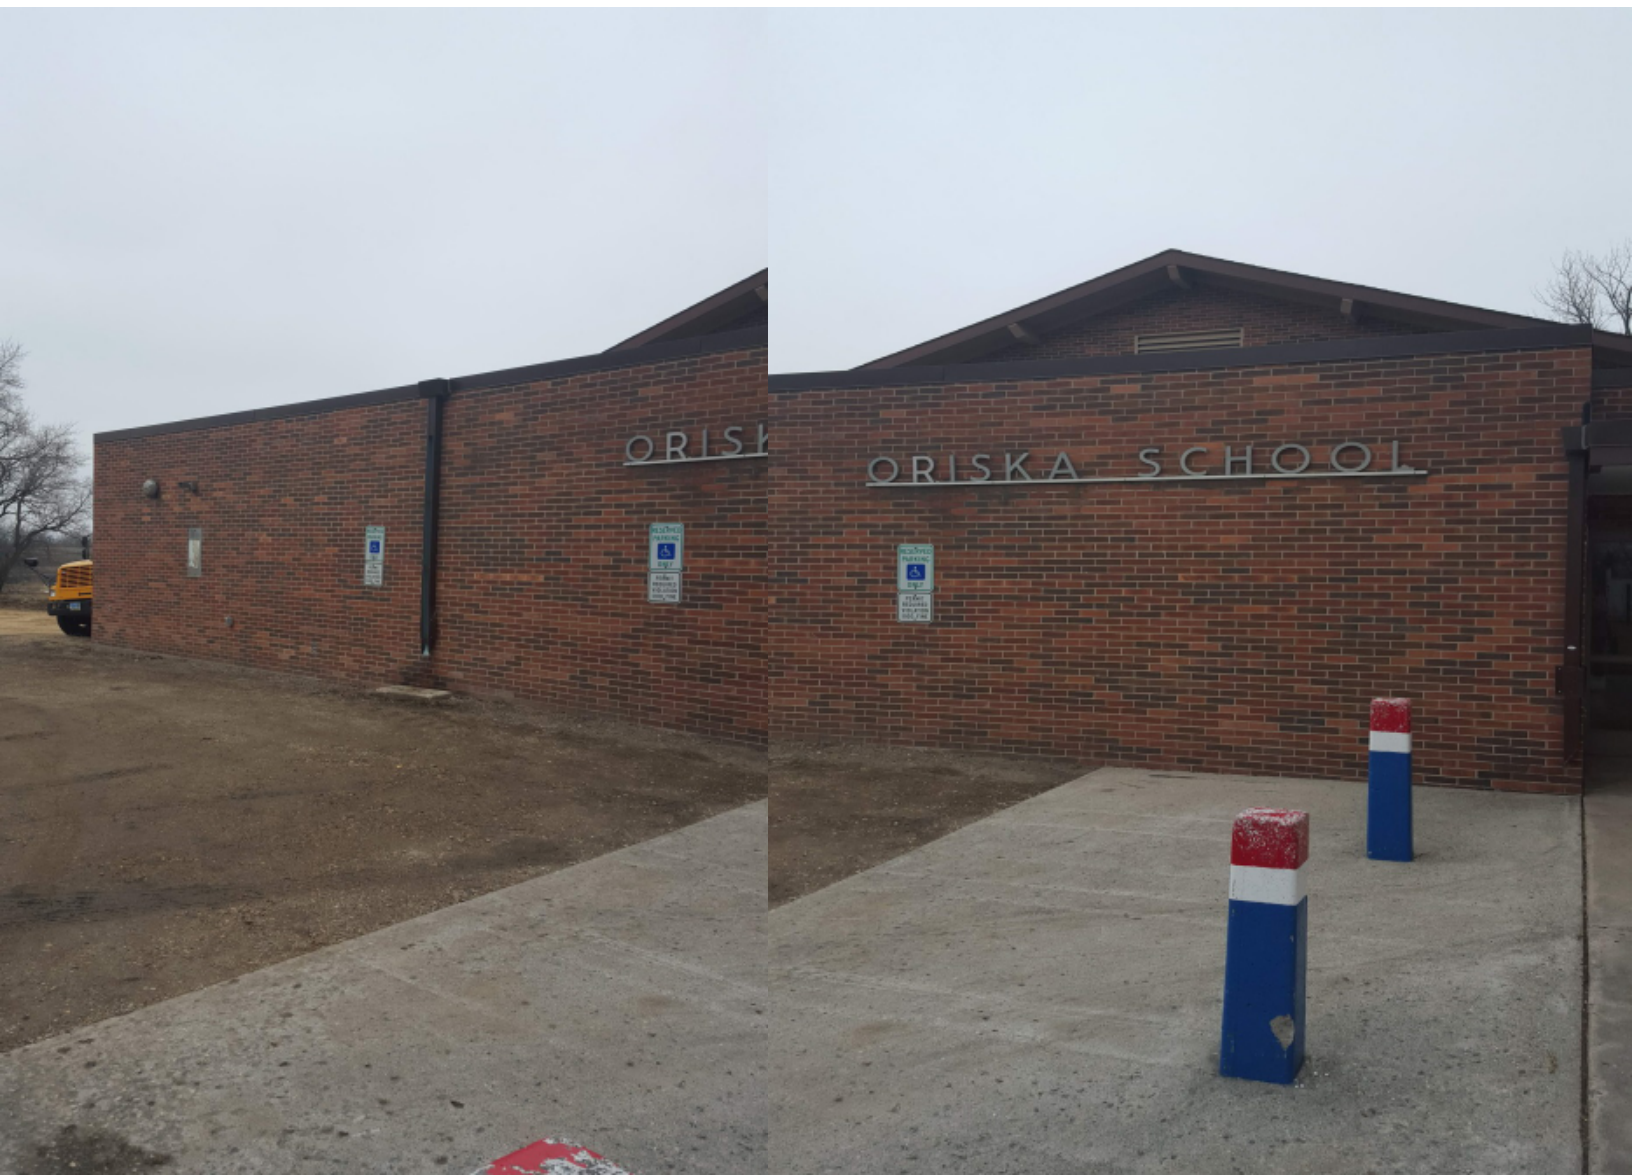
2012 IBC: SECTION 1104.1 SITE ARRIVAL POINTS

- Accessible routes within the site shall be provided from public transportation stops; accessible parking; accessible passenger loading zones; and public streets or sidewalks to the accessible building entrance served.

Corrective Action: Provide paved parking for designated accessible parking.

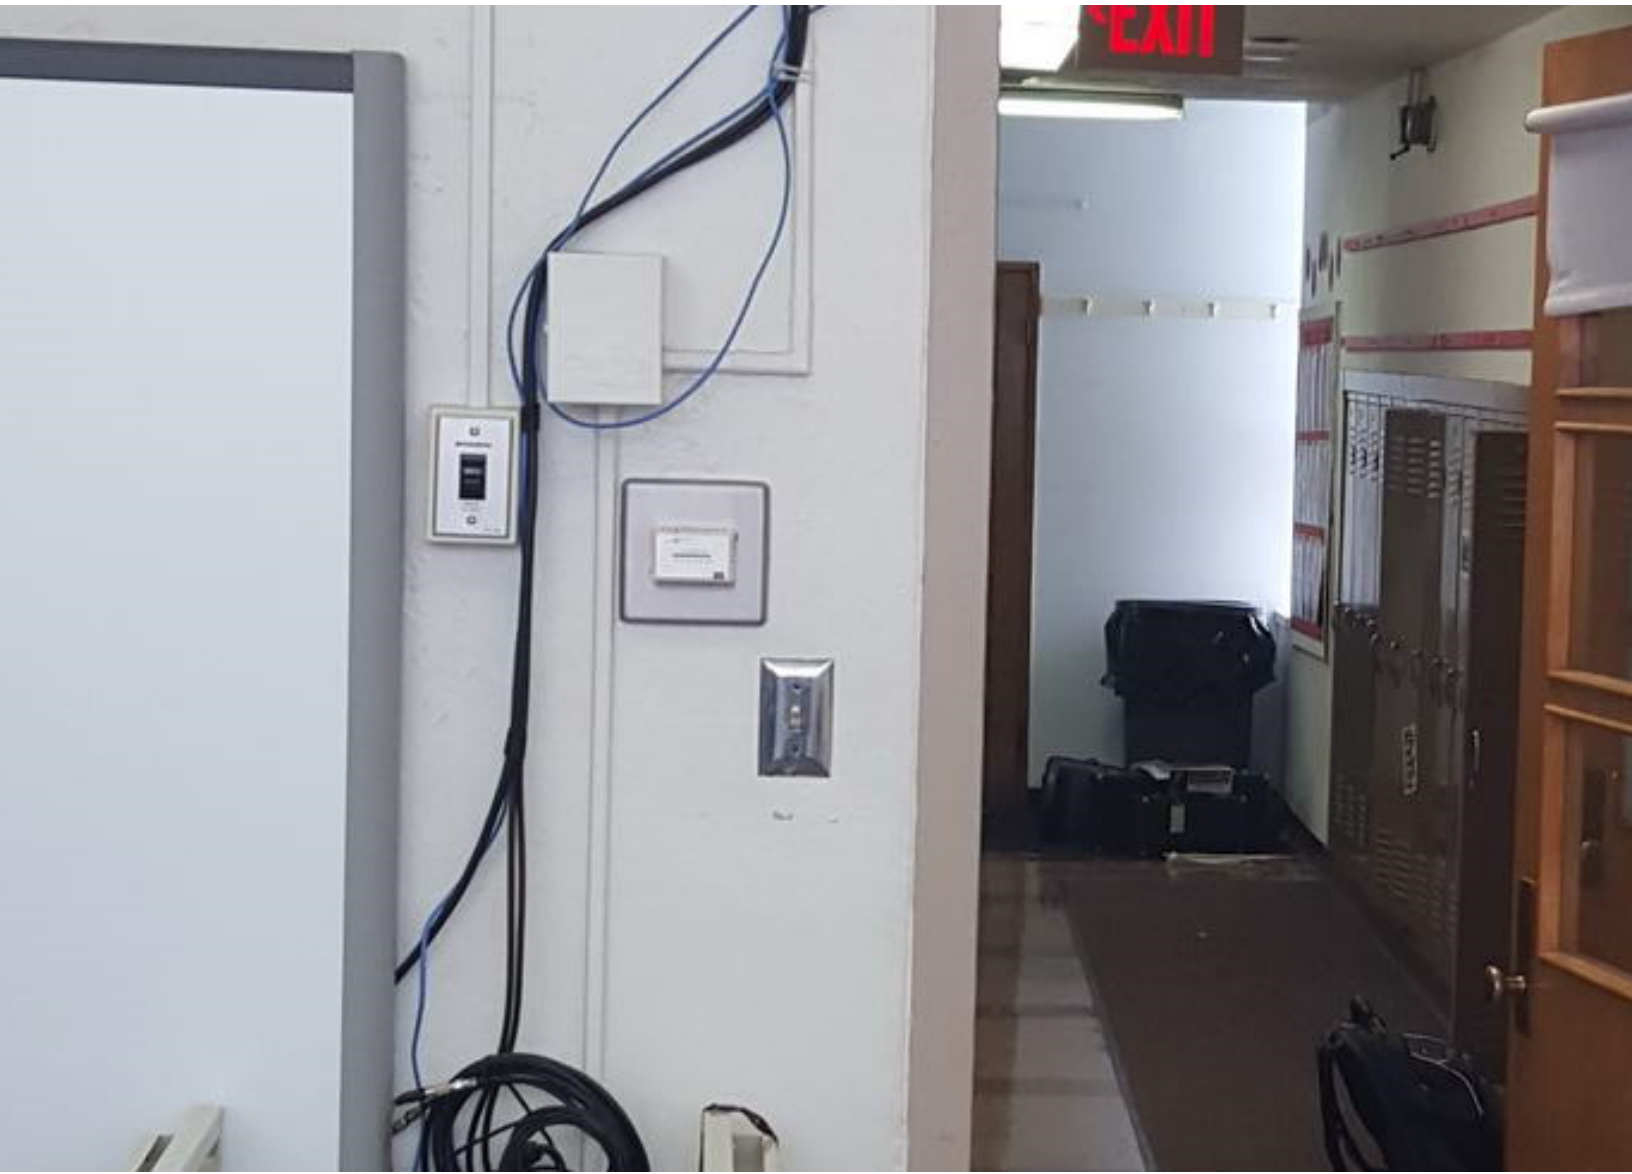
The building control system is an old pneumatic system that needs to be replaced with new DDC building automated control system.

Corrective Action: The building control system is an old pneumatic system that needs to be replaced with new DDC building automated control system.
