**FACILITY ASSESSMENT REPORT
MAPLE VALLEY SCHOOL DISTRICT
BUFFALO SCHOOL
APRIL 2016**

ICON
ARCHITECTURAL GROUP

Karges-Faulconbridge, Inc.
Engineers

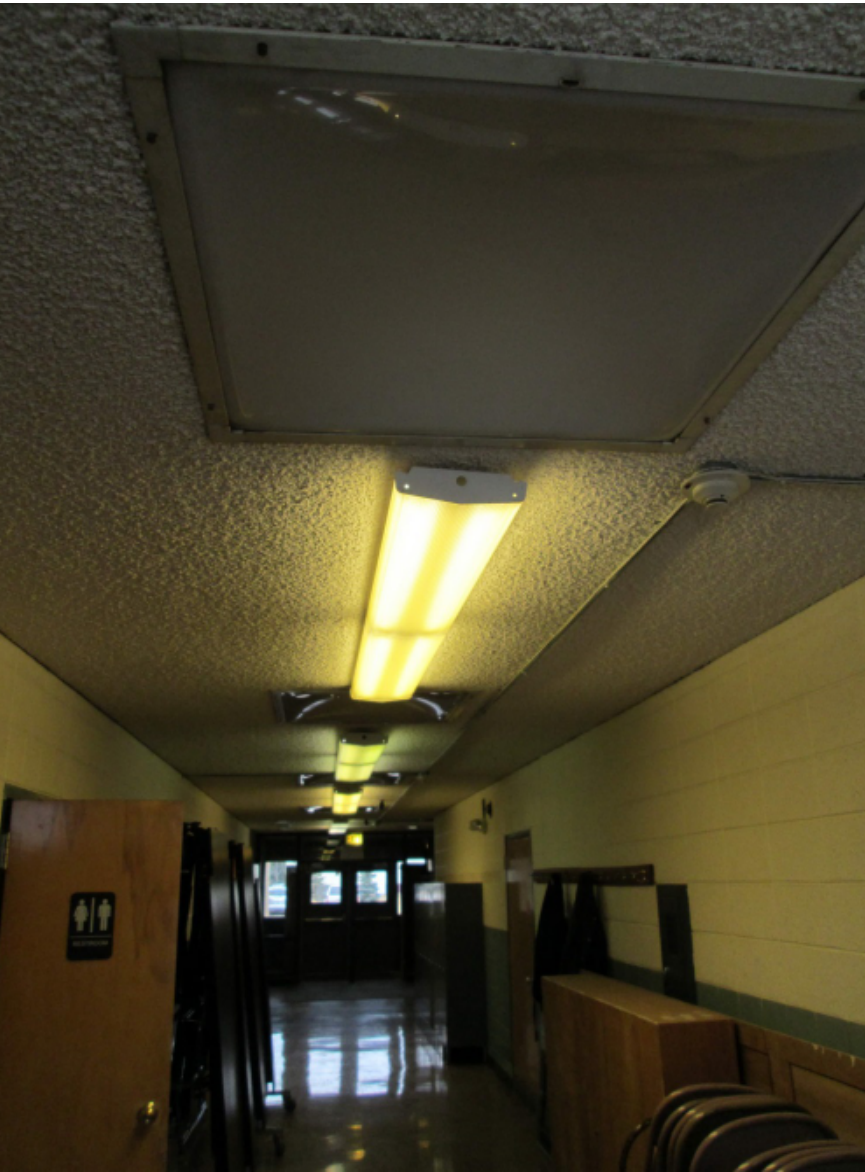
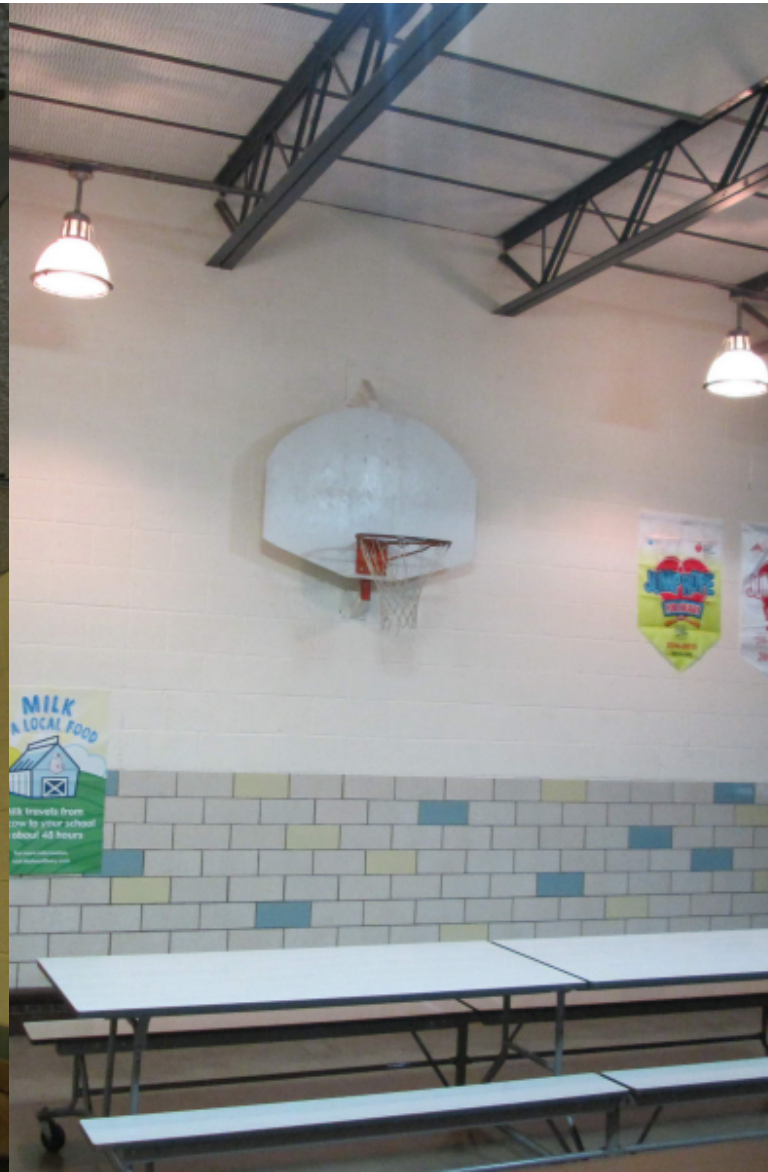
2012 IBC: SECTION 903.2.3 GROUP E

- An automatic sprinkler system shall be provided for Group E occupancies as follows:
 - Throughout all Group E fire areas greater than 12,000 square feet in area.

Corrective Action: Provide automatic sprinkler system throughout existing building. Provide smoke detection in multi-purpose room. Replace light fixtures with energy efficient fixtures.

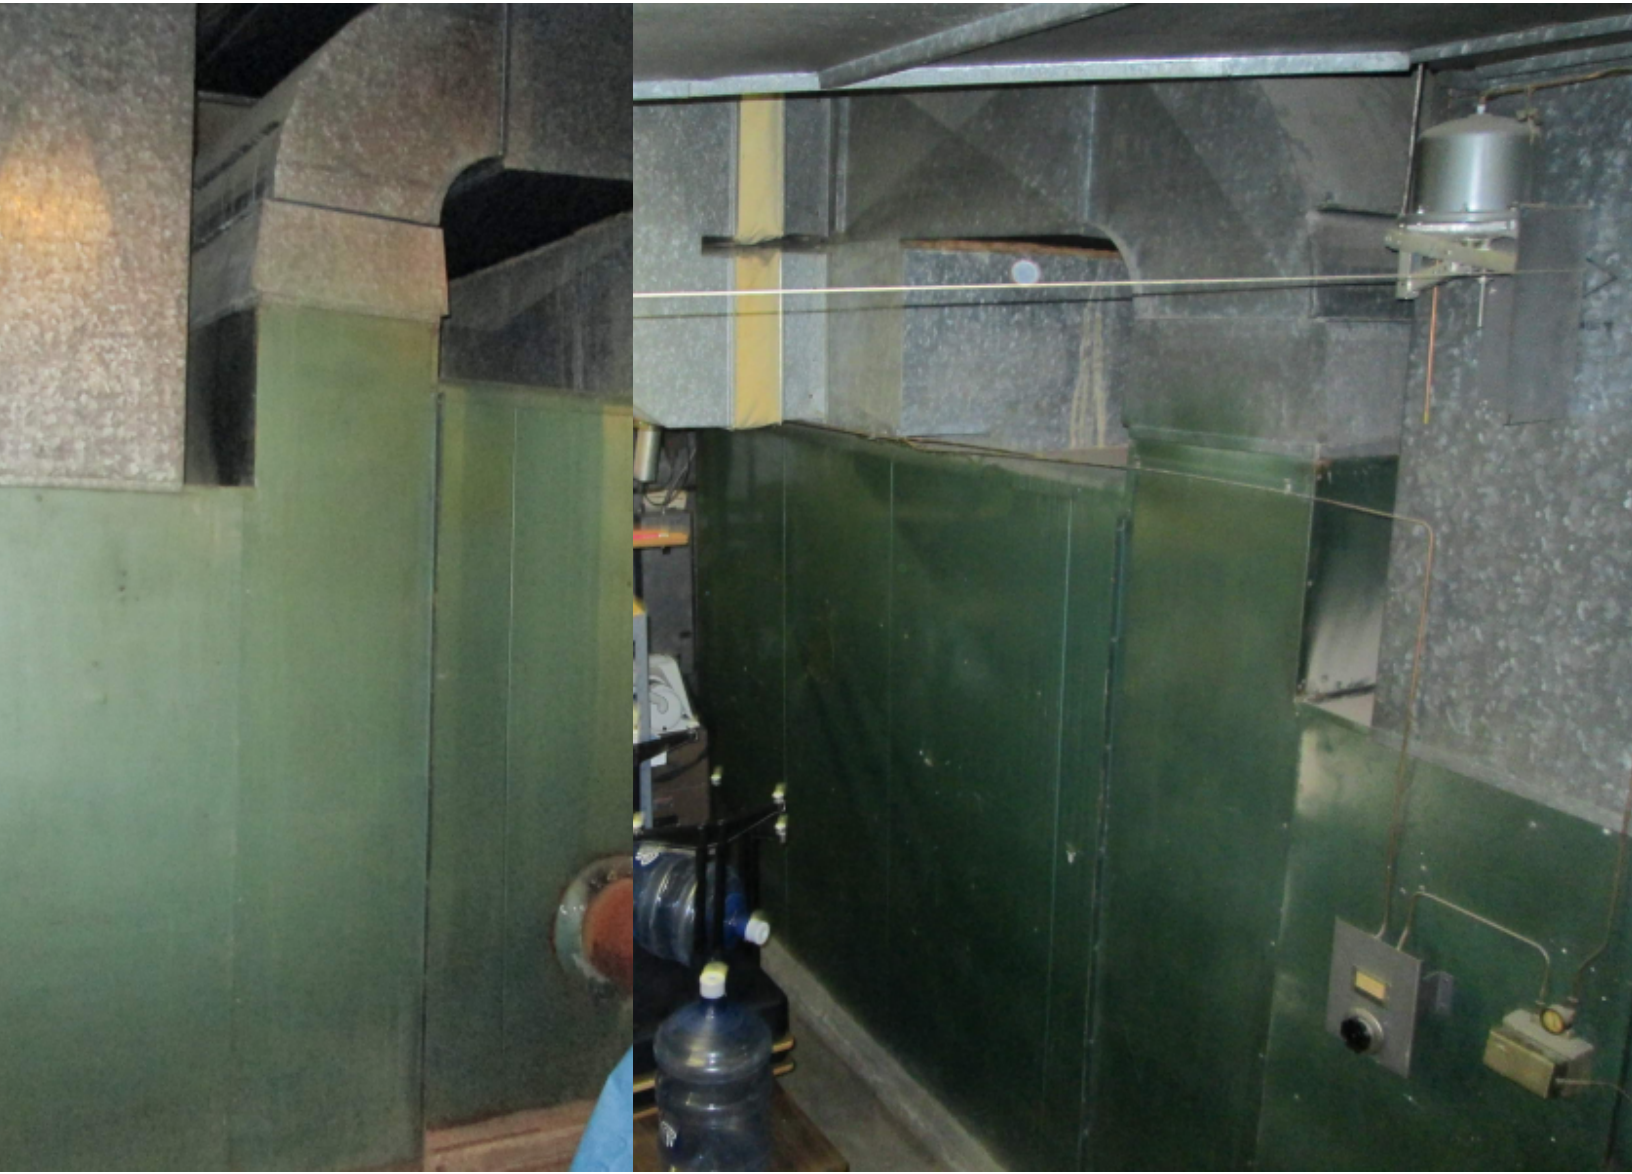
Corrective Action: The existing central air handling system is original to the 1958 building with two additional zones added to the central system as part of the 1979 addition. The existing central system is a large gas furnace with electric reheats. Electric reheats are the primary heating source with the gas furnace operating as a backup system. The system is past its useful life and is in need of replacement. The gas burner was replaced in 2002. There is no air conditioning associated with the central air handling system.

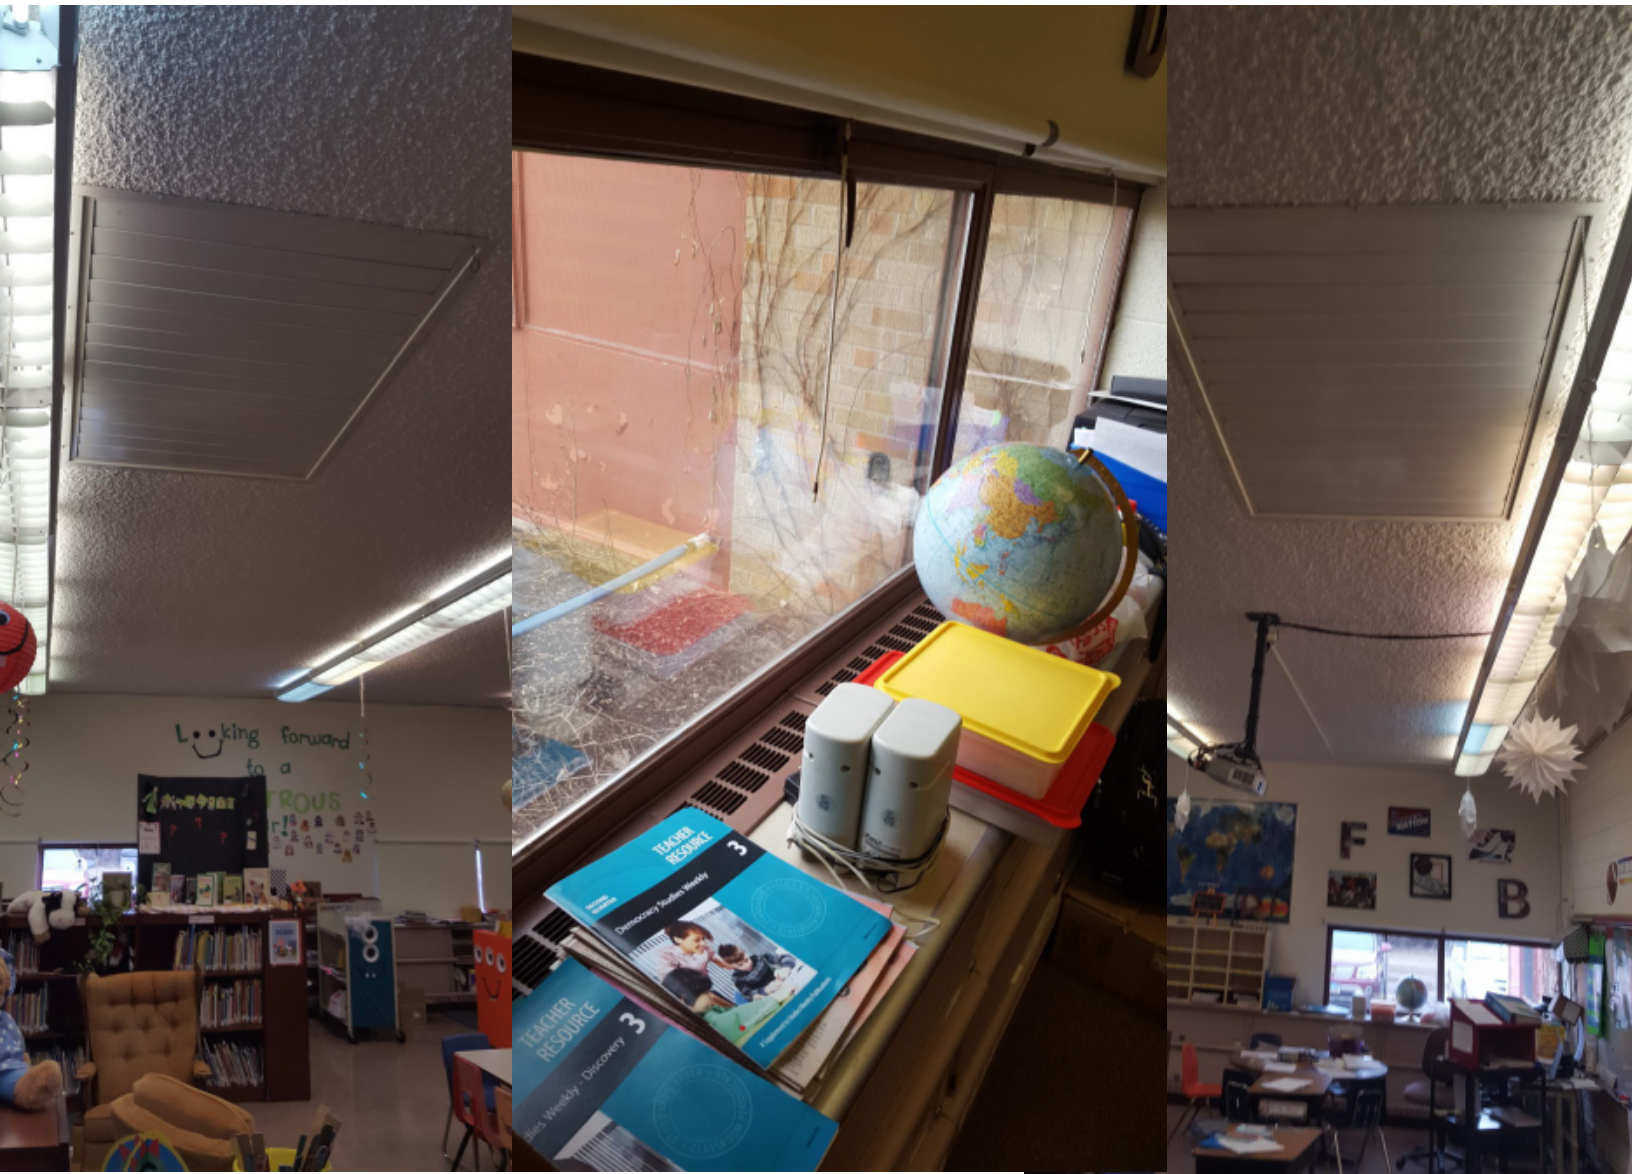
Corrective Action: There is no air conditioning associated with the central air handling system. The central air handling system distributes air through ductwork via the tunnels to each space in the building. Return air is returned through the corridor ceiling via return grilles above the classroom doors. The original relief vents in each classroom have been capped off. Existing HVAC system does not meet current ventilation or energy code requirements.

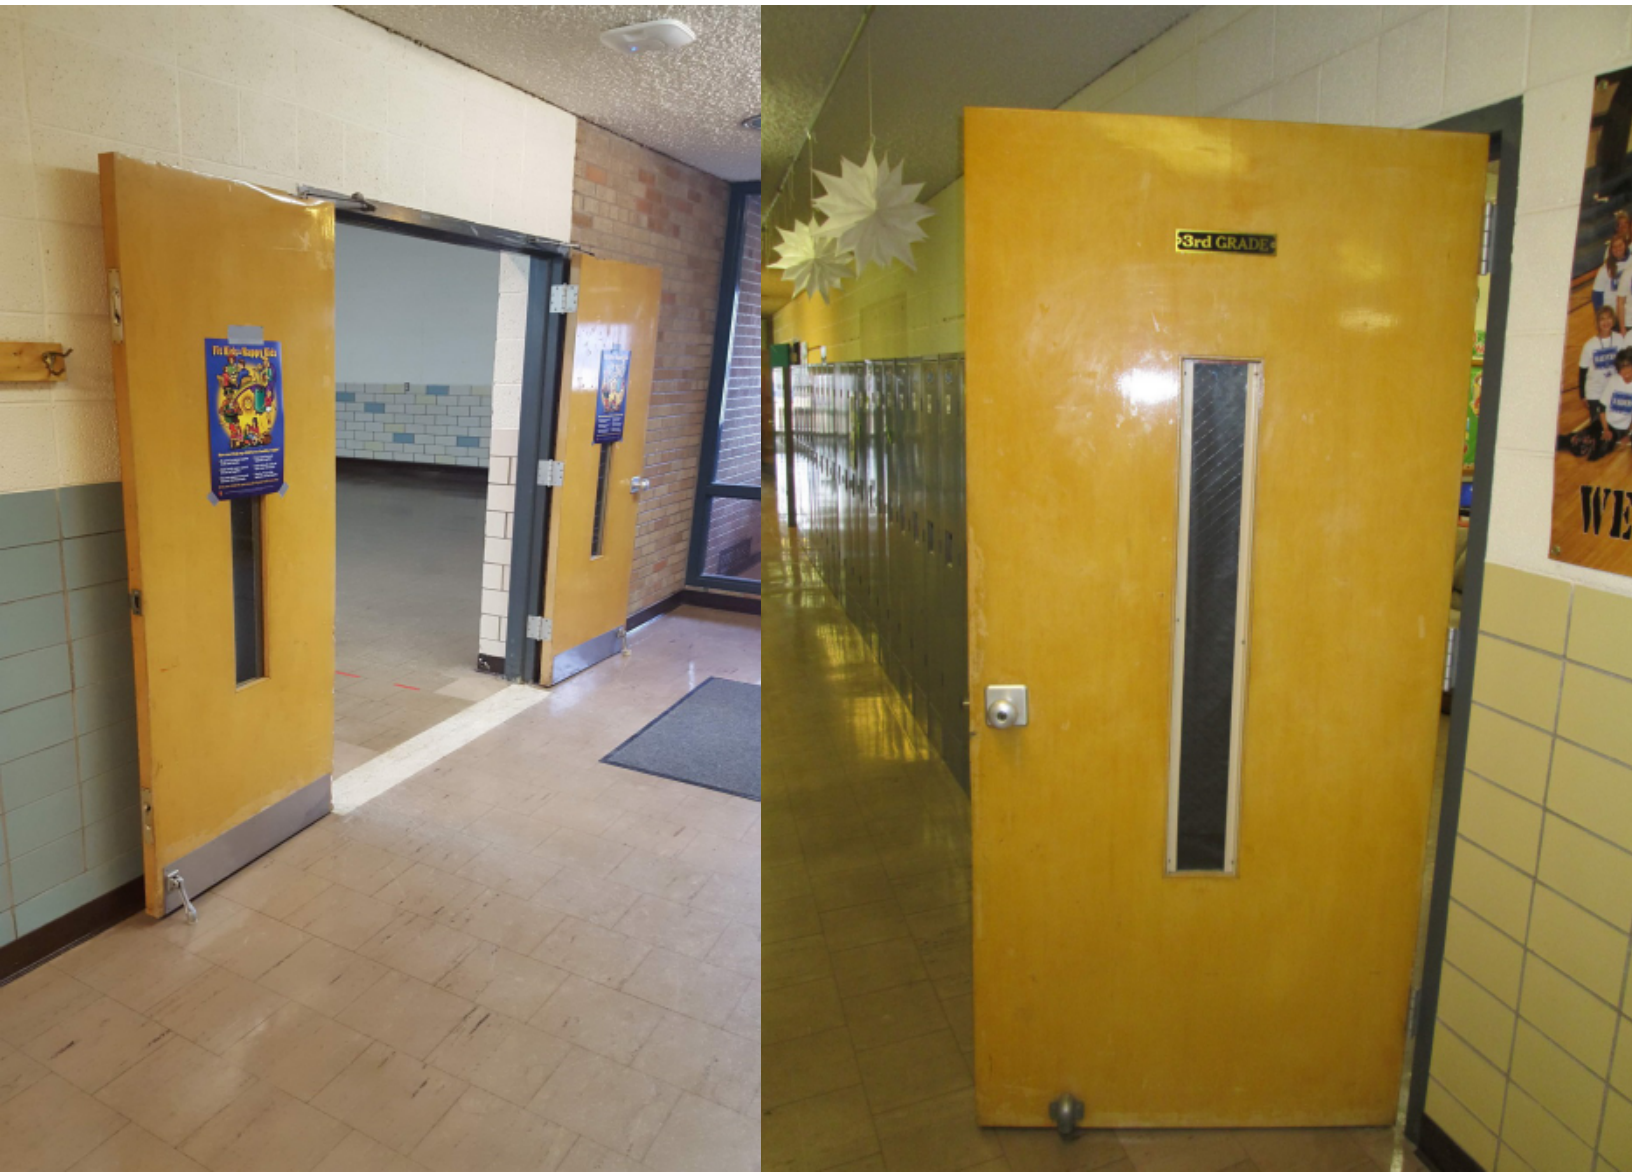
2012 IBC: SECTION 716.5.3 DOOR ASSEMBLIES IN CORRIDORS AND SMOKE BARRIERS

- Fire door assemblies required to have a minimum fire protection rating of 20 minutes where located in corridor walls or smoke barrier walls

2012 IBC: SECTION 1008.1.9.1 HARDWARE

- Door handles, pulls, latches, locks and other operating devices on doors required to be accessible by Chapter 11 shall not require tight grasping, tight pinching or twisting of the wrist to operate.

Corrective Action: Replace all doors and frames in corridors with properly fire-rated doors and frames including fire-rated glass and louvers. Replace all door hardware with accessible hardware.

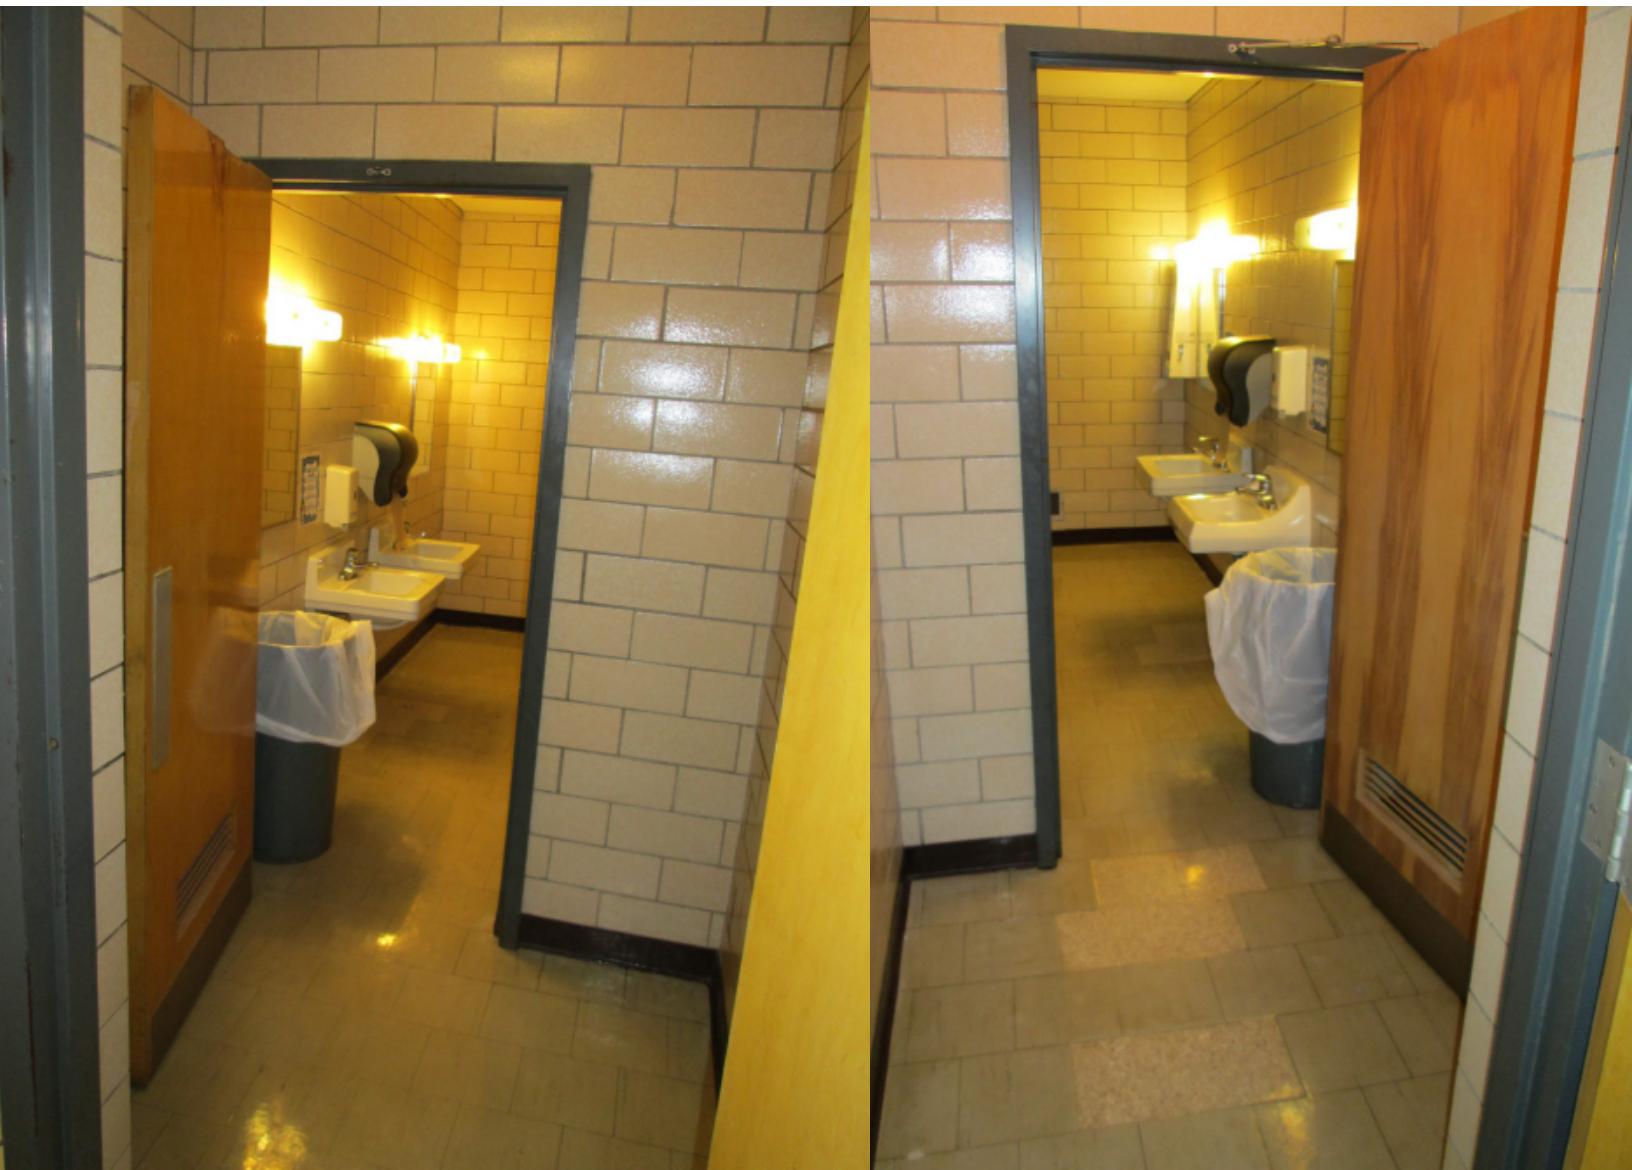
2012 IBC: SECTION 1109.2 TOILET AND BATHING FACILITIES

- Each toilet room and bathing room shall be accessible.

Corrective Action: Bathrooms will be required to be renovated to provide clearances to make restrooms accessible.

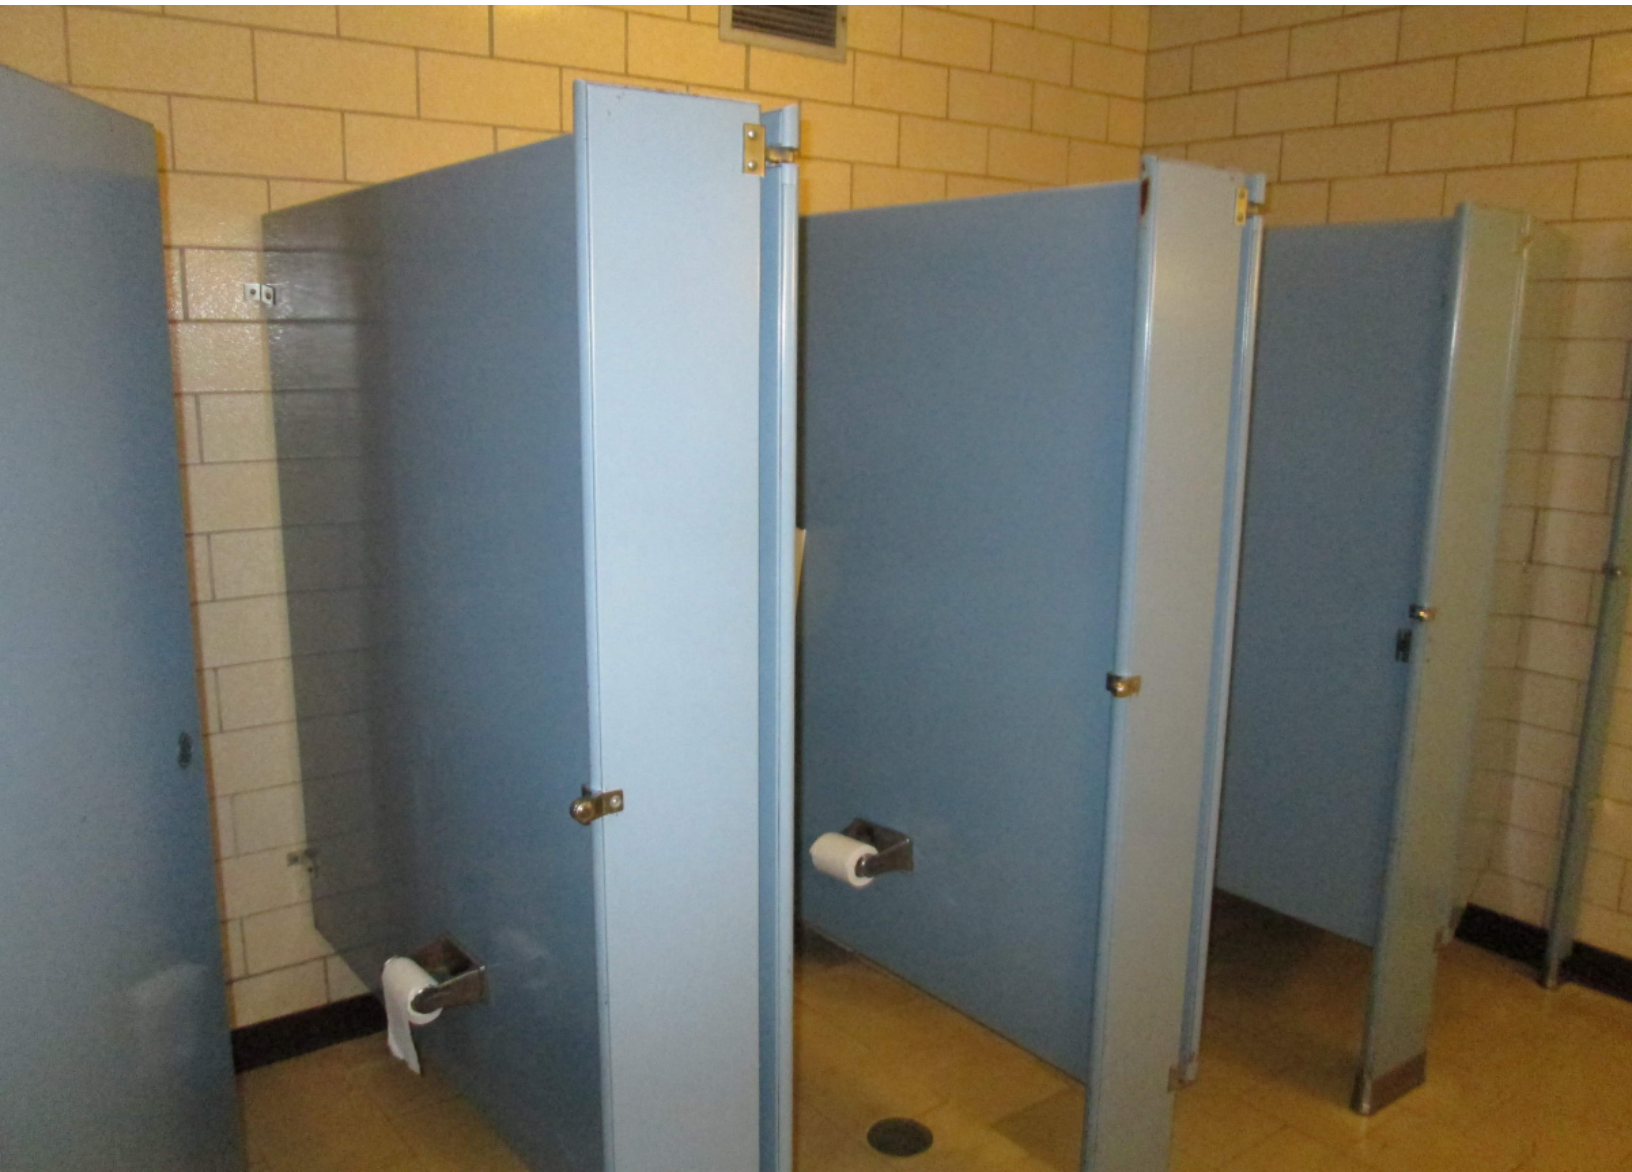
2012 IBC: SECTION 1109.2 TOILET AND BATHING FACILITIES

- Each toilet room and bathing room shall be accessible. At least one of each type of fixture, element, control or dispenser in each accessible toilet room and bathing room shall be accessible.

Corrective Action: Provide accessible toilet compartments and add fixtures to meet required plumbing counts.

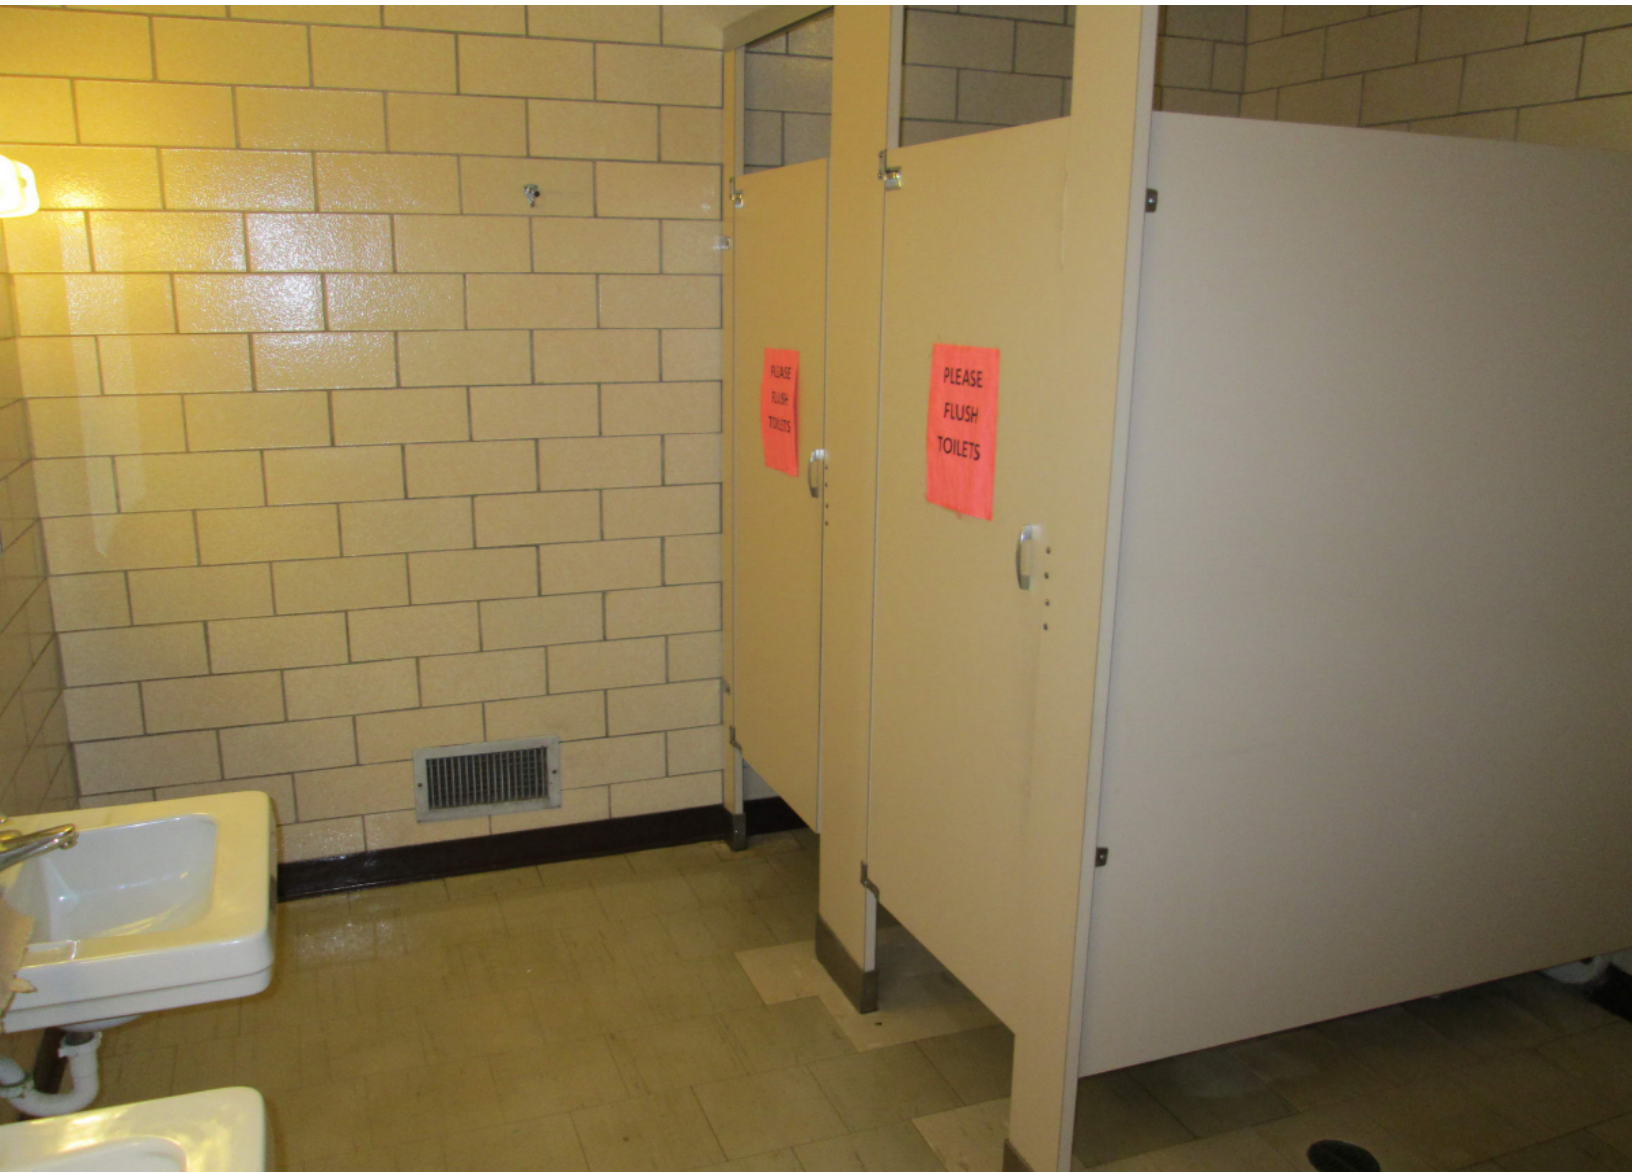
2012 IBC: SECTION 1109.2 TOILET AND BATHING FACILITIES

- Each toilet room and bathing room shall be accessible. At least one of each type of fixture, element, control or dispenser in each accessible toilet room and bathing room shall be accessible.

Corrective Action: Provide accessible toilet compartments and add fixtures to meet required plumbing counts.

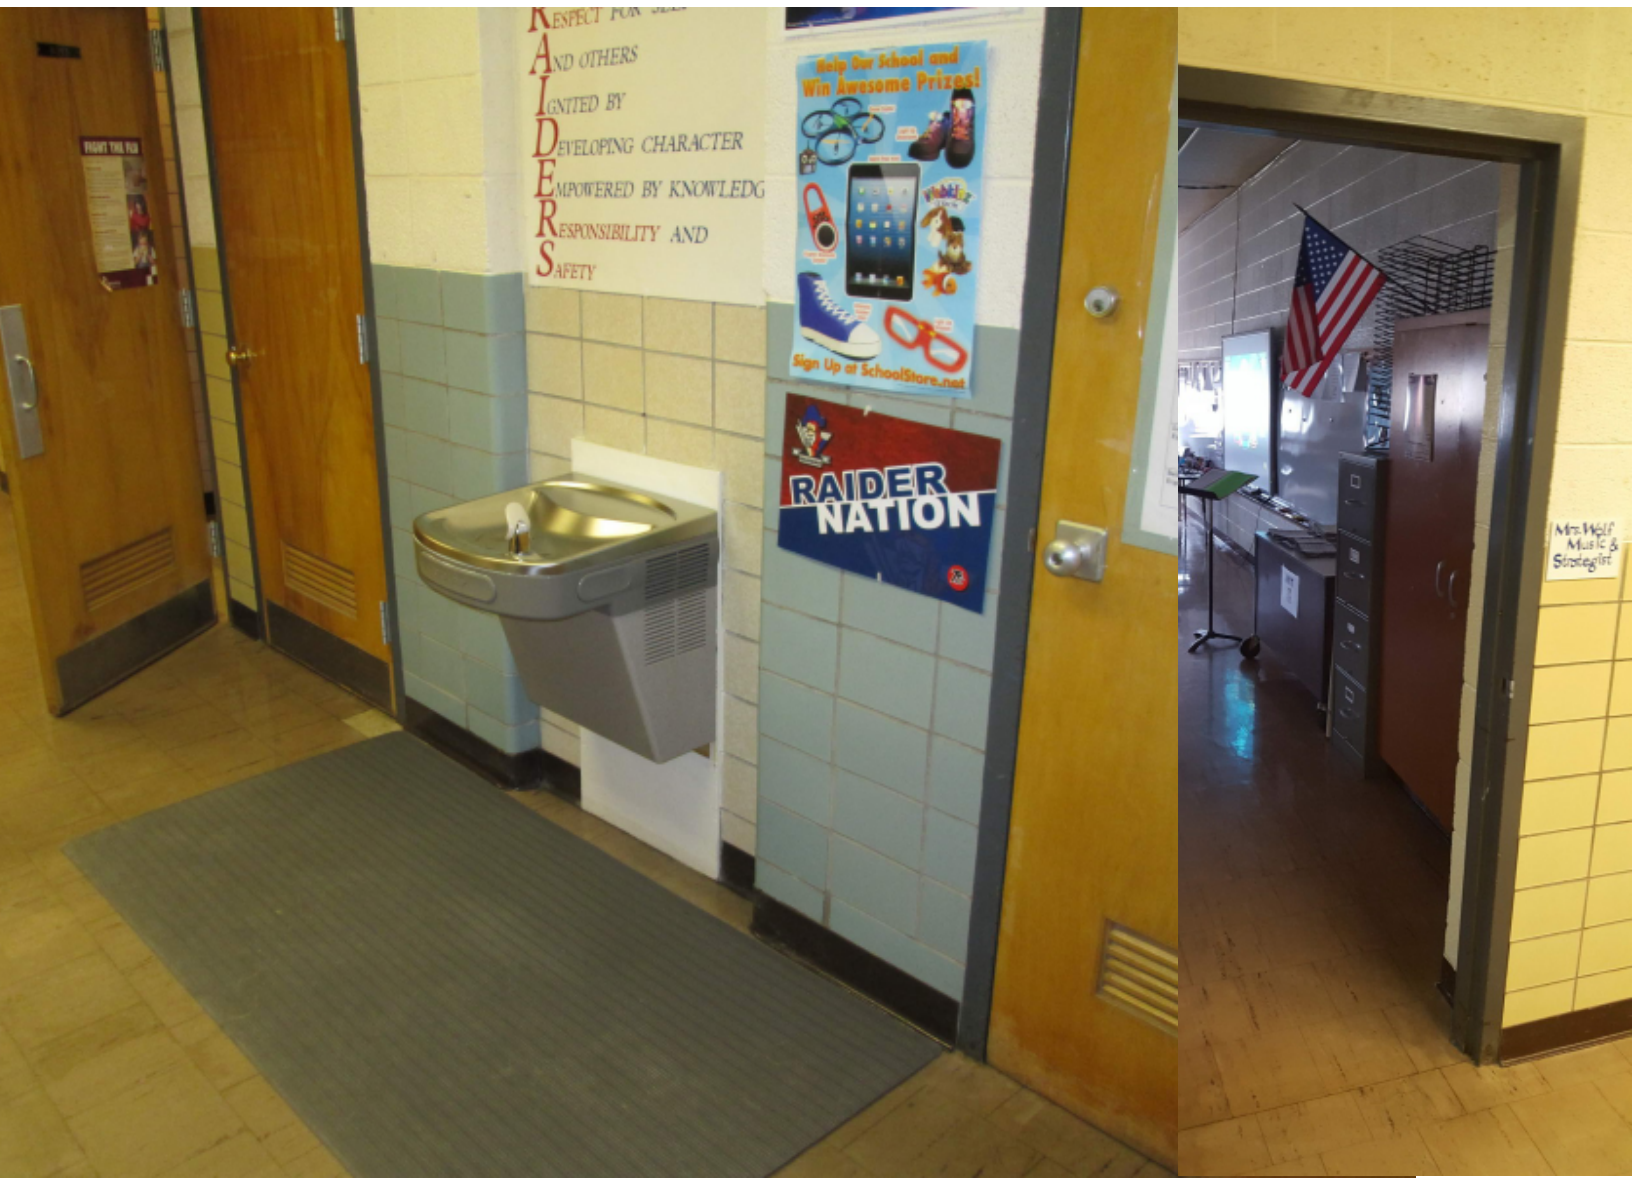
2012 IBC: SECTION 1110.1 Signs

- Required accessible elements shall be identified by the International Symbol of Accessibility.

Corrective Action: Provide signage indicating accessibility provisions at all entrances, and rooms required to be accessible.

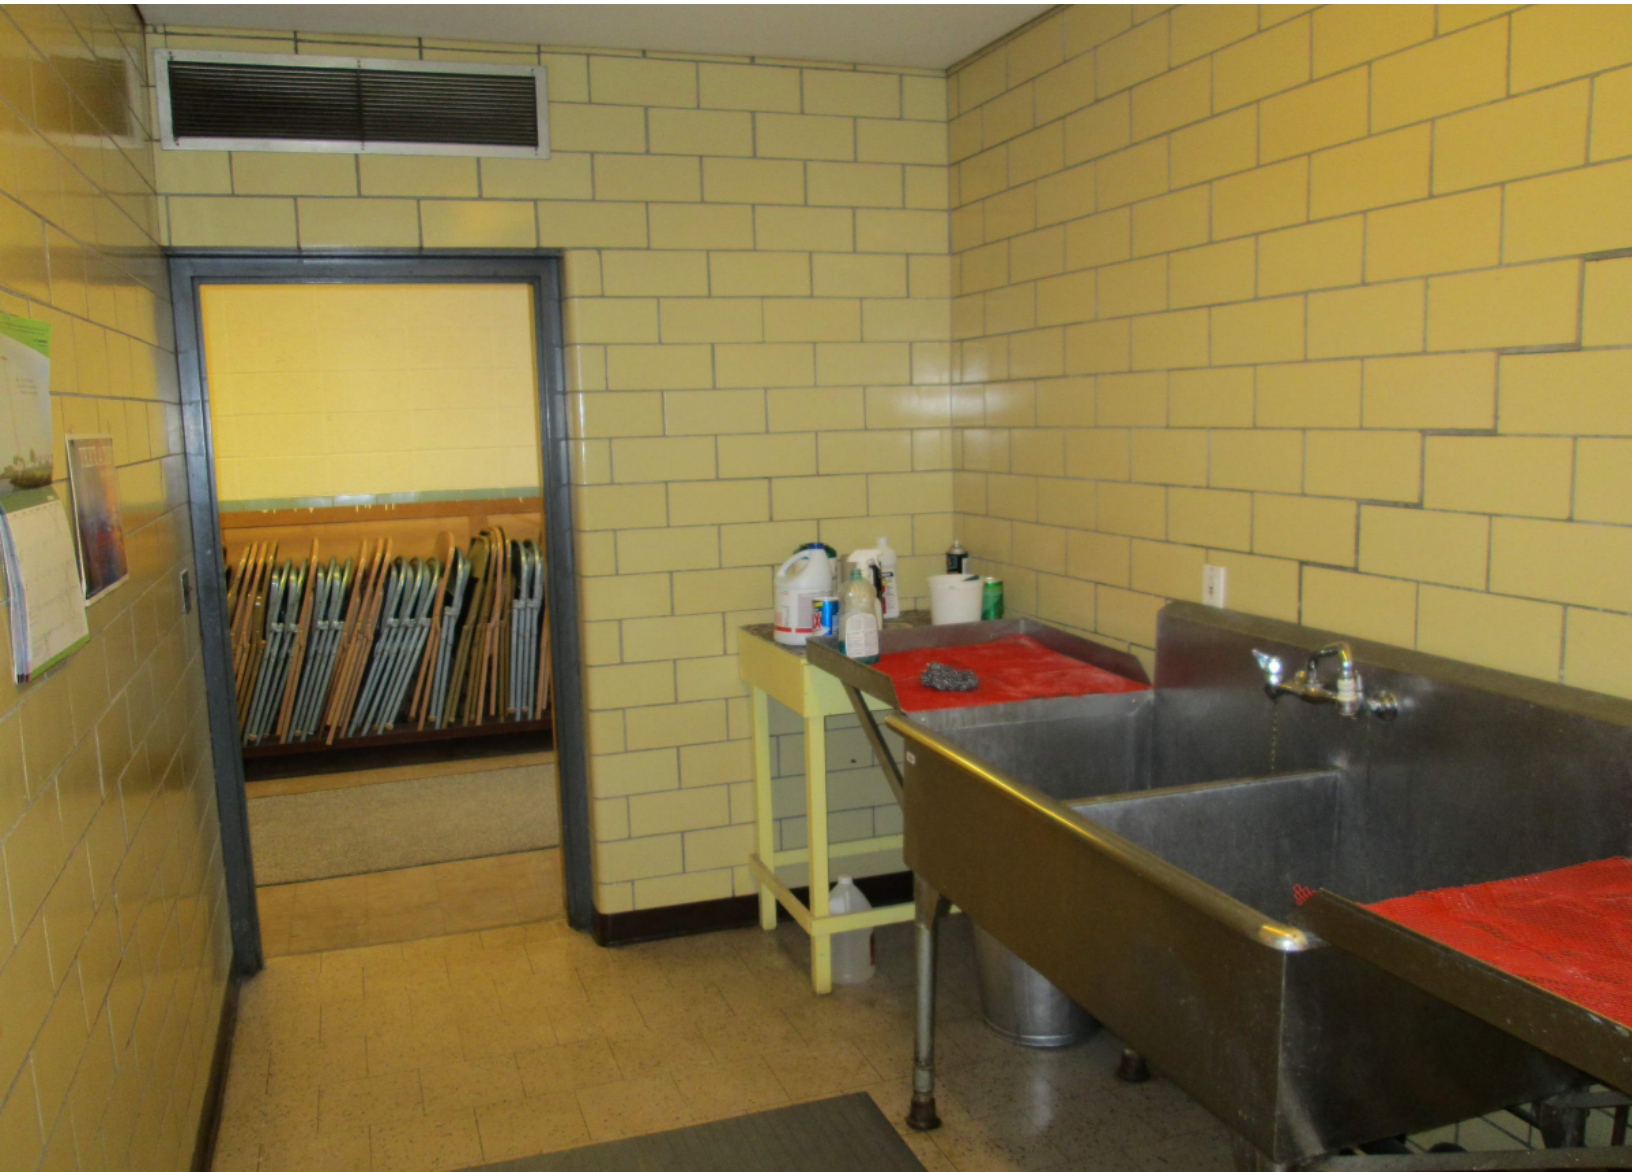
Corrective Action: Displacement and cracking of tile in kitchen suggests movement in wall and possible structural deficiency.

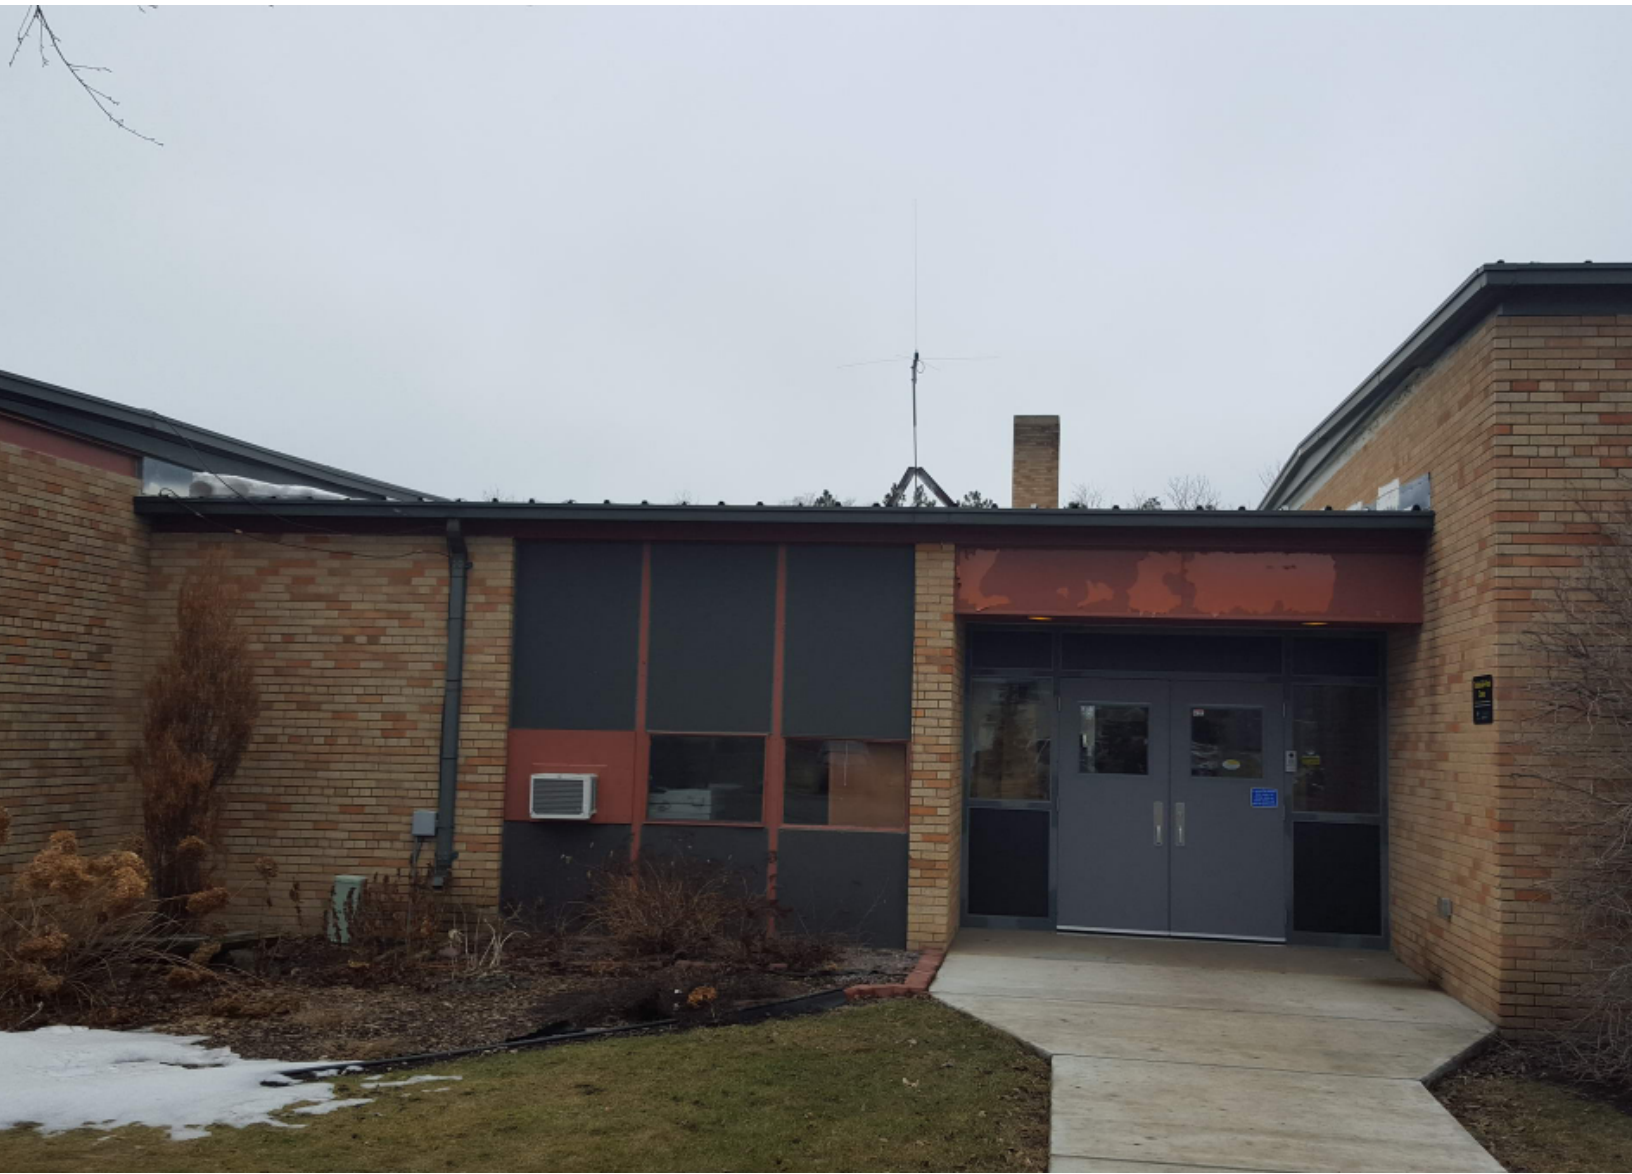
2012 IBC: SECTION 1104.1 SITE ARRIVAL POINTS

- Accessible routes within the site shall be provided from public transportation stops; accessible parking; accessible passenger loading zones; and public streets or sidewalks to the accessible building entrance served.

Corrective Action: Provide paved parking for designated accessible parking.

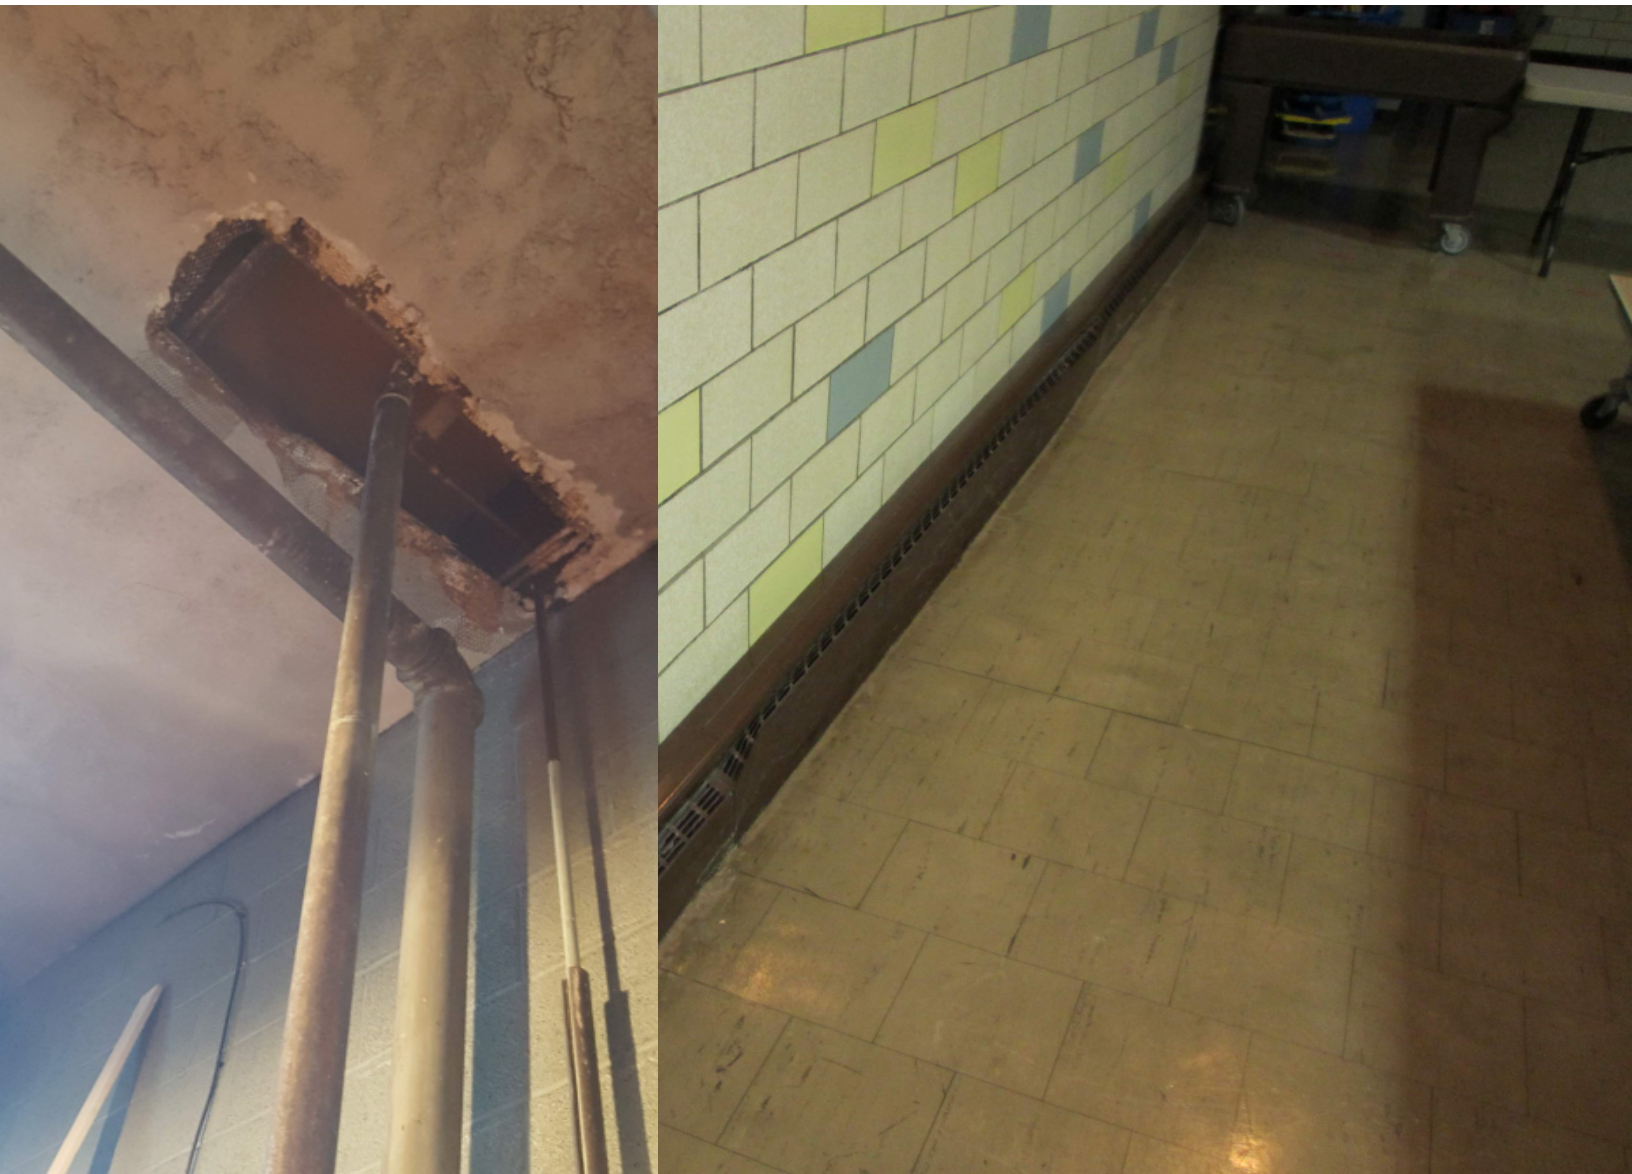
Corrective Action: The flooring, most plaster walls, pipe insulation and other components of the building contain asbestos and would require abatement prior to any new construction or renovation.
