**FACILITY ASSESSMENT REPORT**

**HARVEY PUBLIC SCHOOL DISTRICT 38**

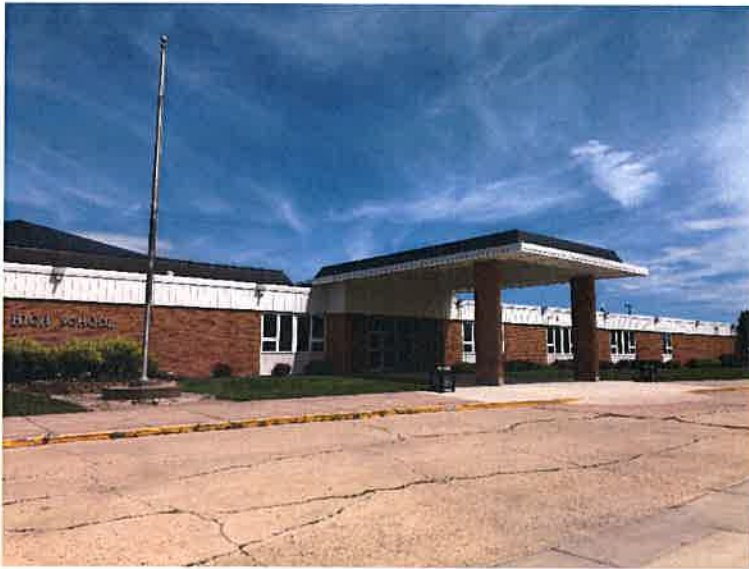
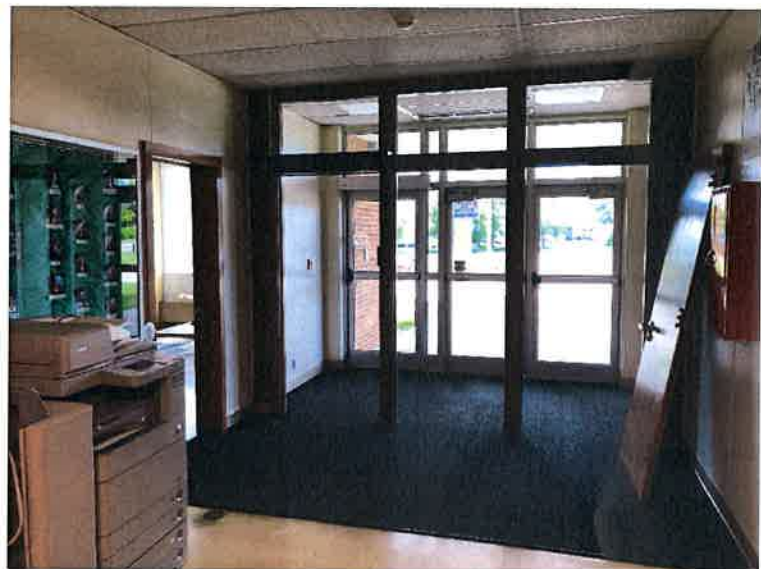
Concrete drive and curb are damaged/cracked

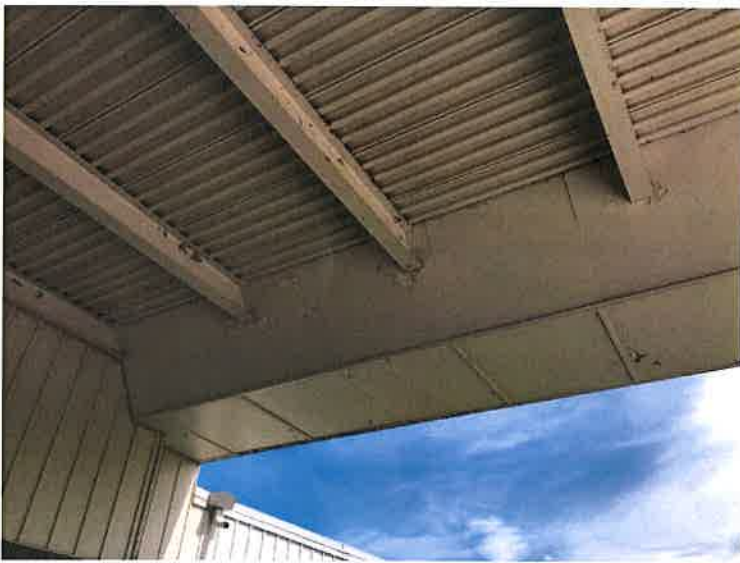
Front entrance canopy paint peeling

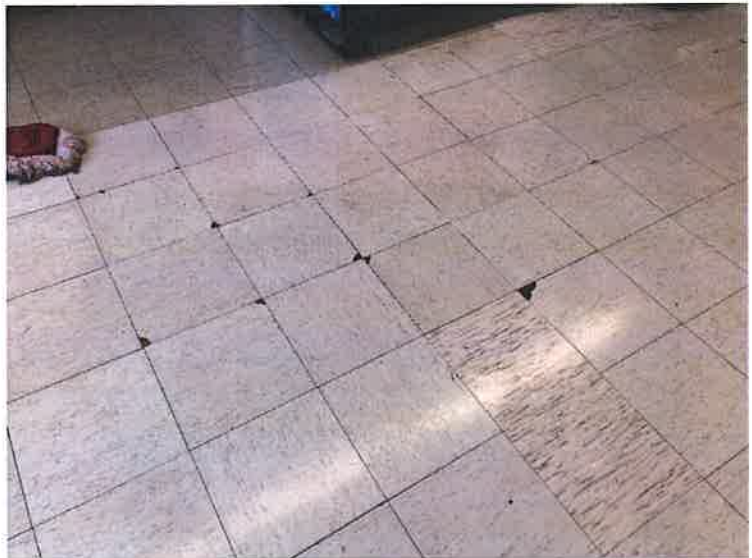
VCT flooring needs to be replaced in various locations

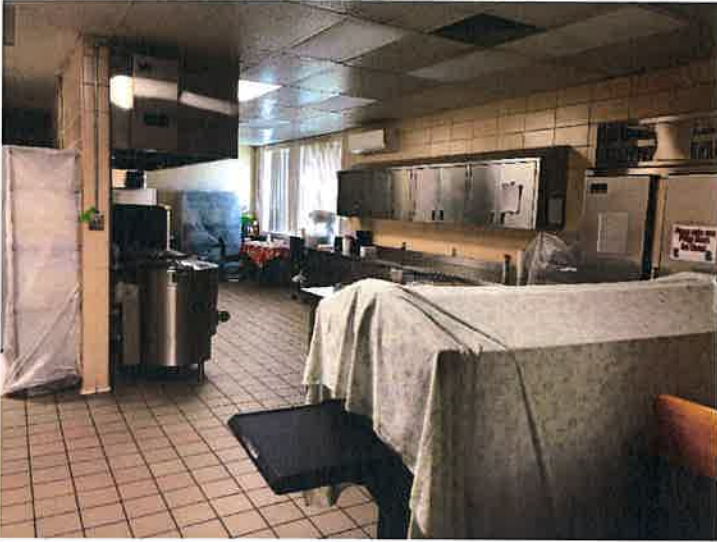
Kitchen is required to have cleanable/scrubbable acoustic ceiling tile

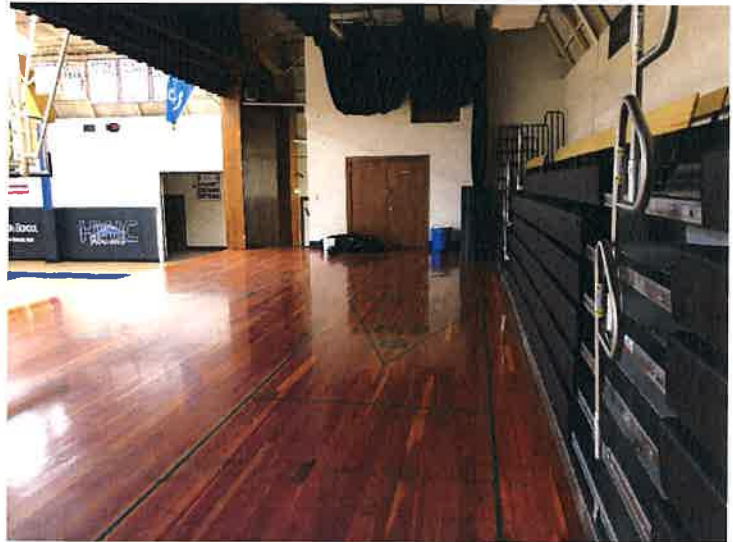
Missing fall protection (guard railing) at stage front when bleachers are used

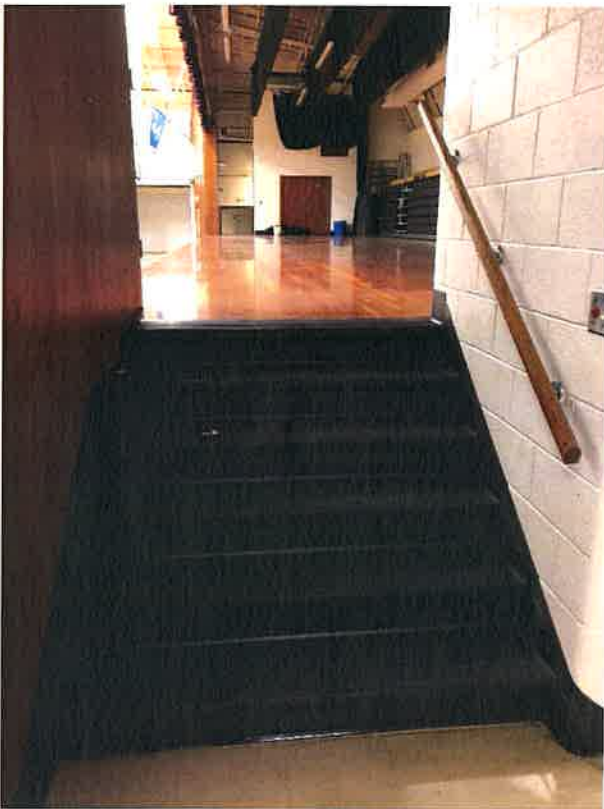
Stage is not handicap accessible – missing a handrail

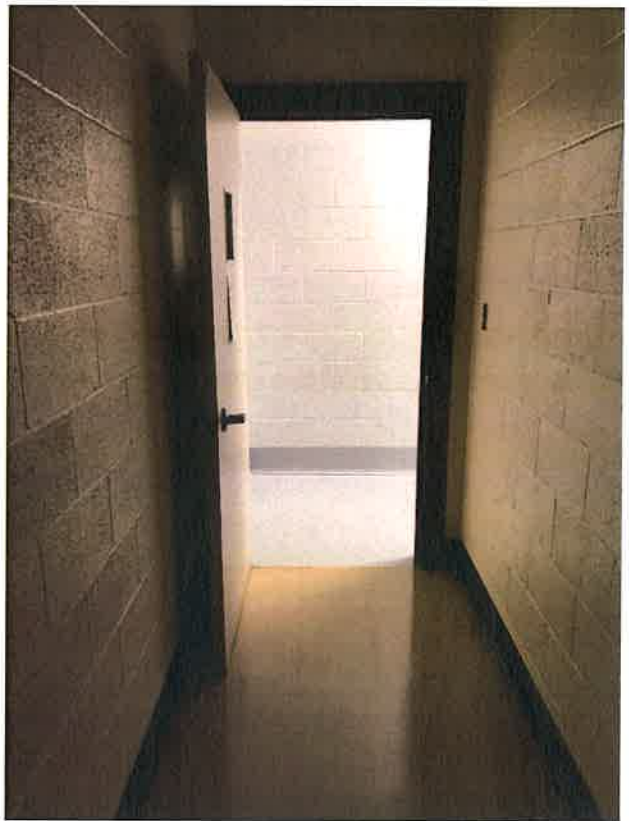
Many doors do not meet push/pull handicap accessibility clearance requirements

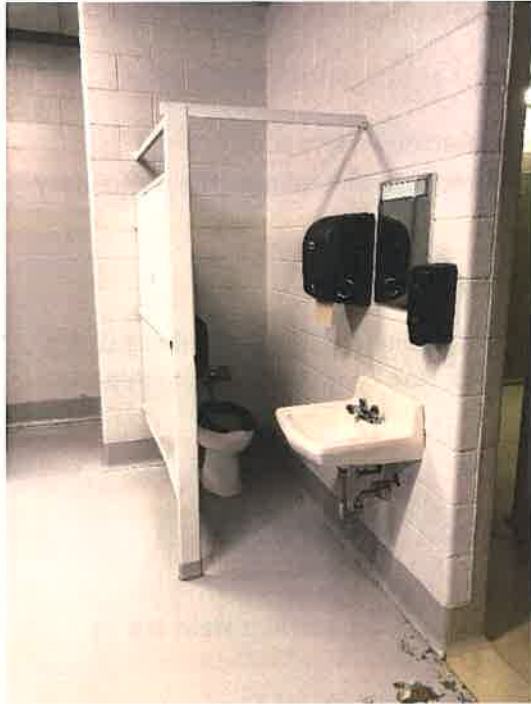
In the locker room the toilet stall does not meet handicap accessibility and floor paint needs to be repaired

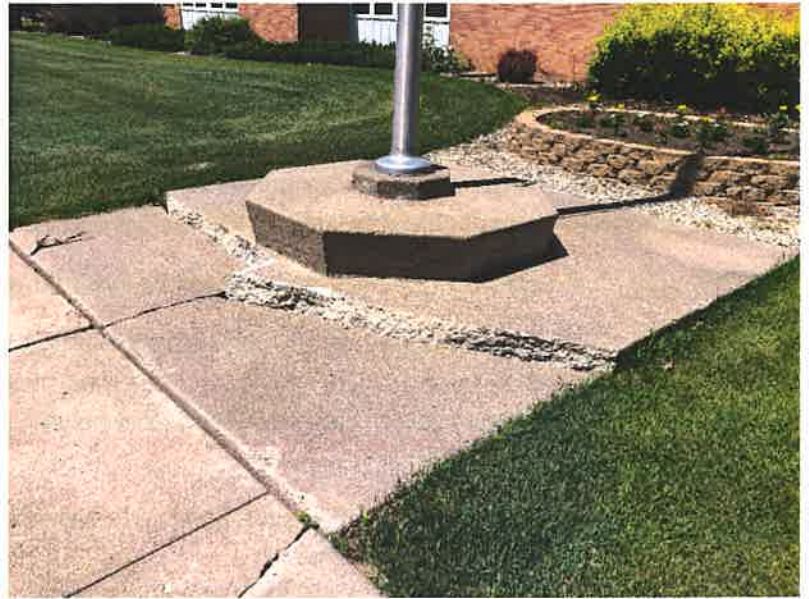
Pavement/sidewalk is cracked and heaved

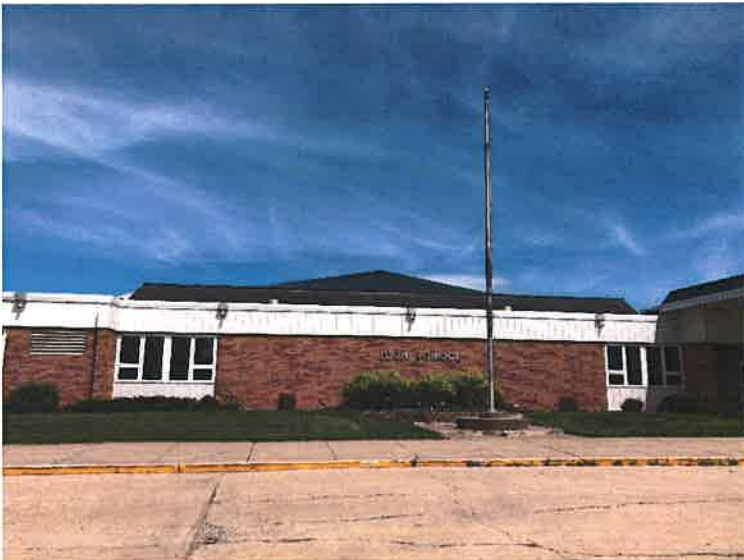
Downspouts do not extend down to the ground

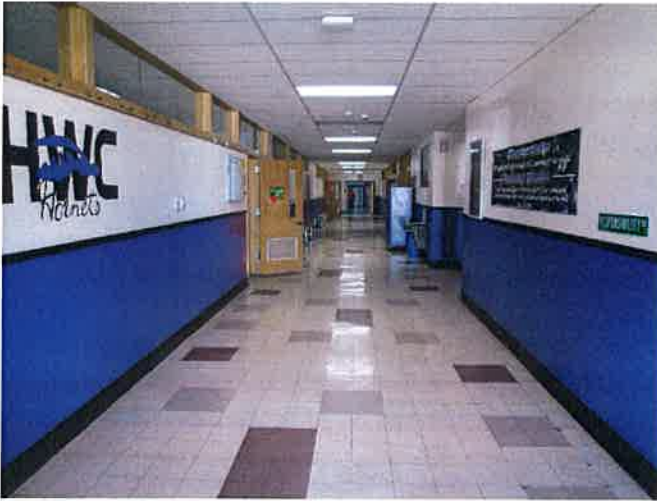
Corridors are not fire rated - cannot have glazing at corridor walls and doors cannot have louvers if the building isn't sprinklered

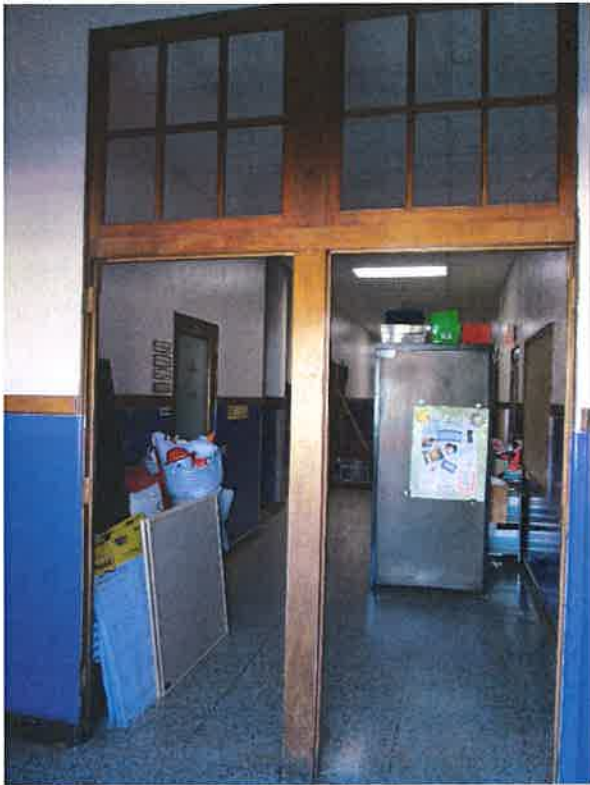
Vestibule doors missing

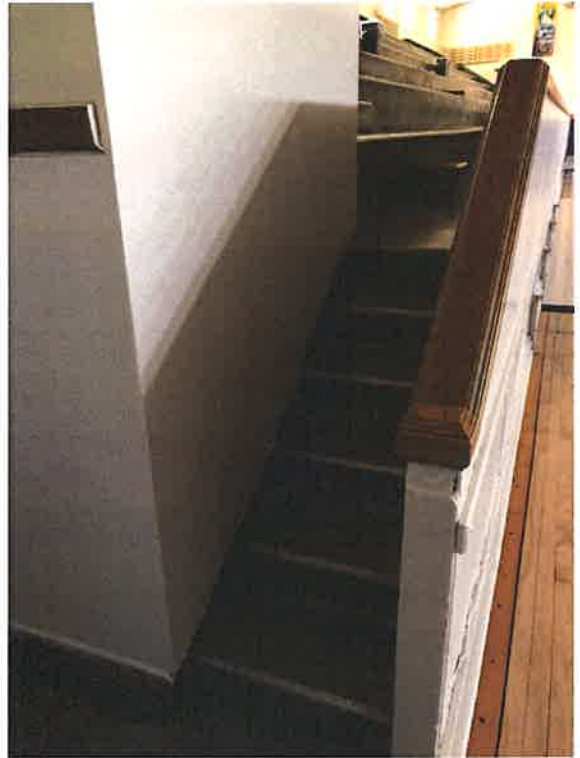
Stadia stairs are too narrow, are missing handrails, and the guard railing is too low

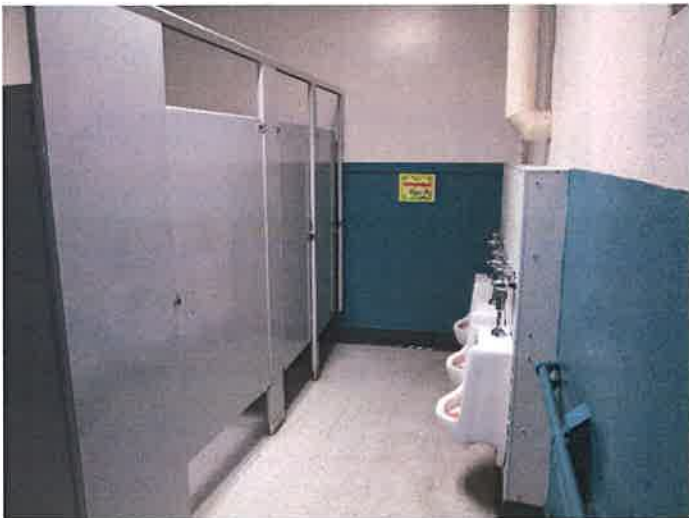
Restrooms do not meet ADA clearances

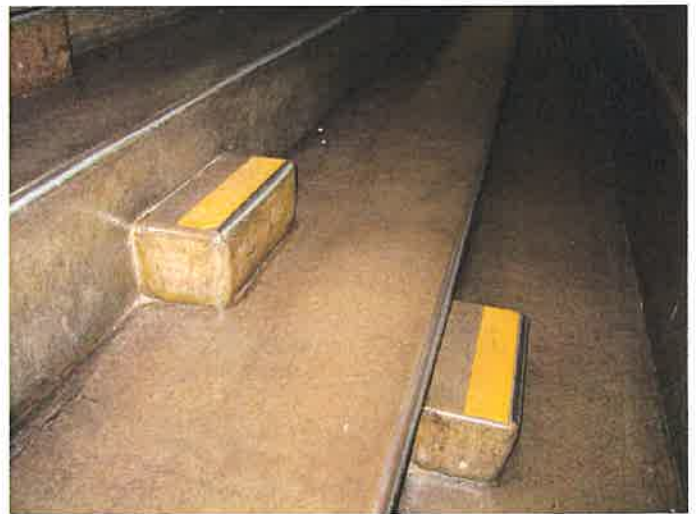
Stadia stairs are missing intermediate handrails and are too narrow

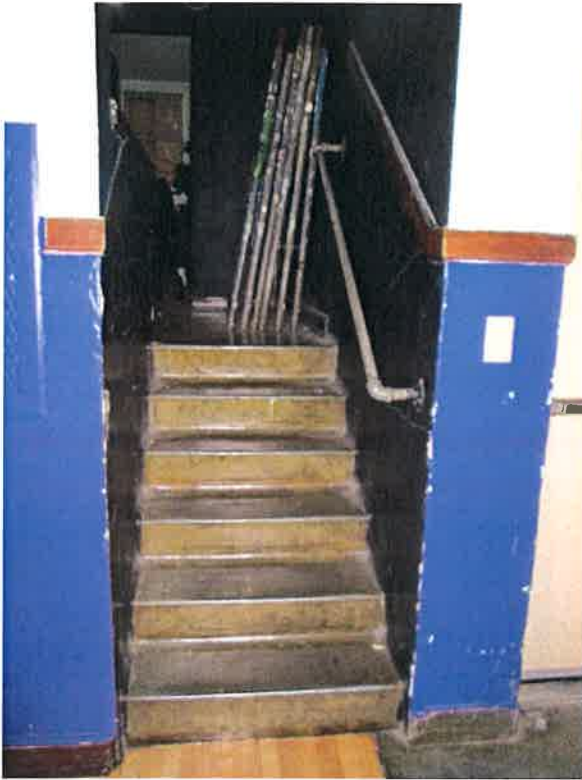
The stage is not handicap accessible – the stair handrail is not ADA compliant

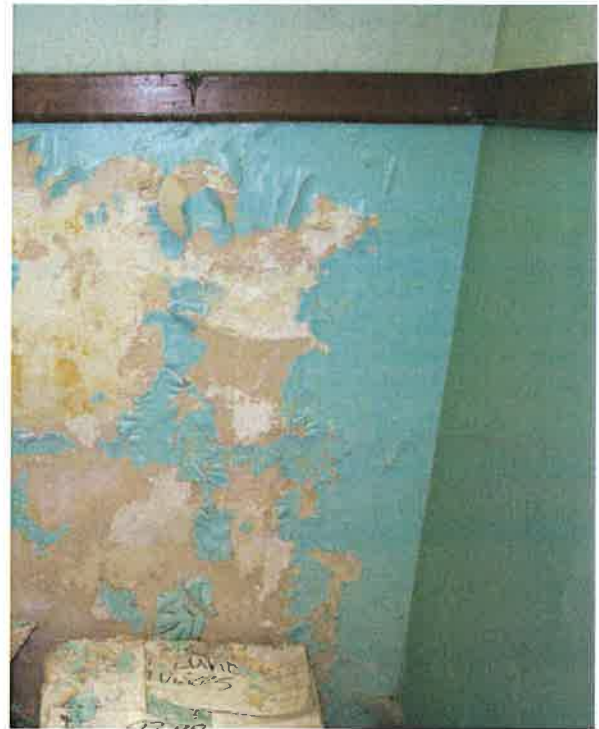
Storage under the stage has water infiltration and potential mold

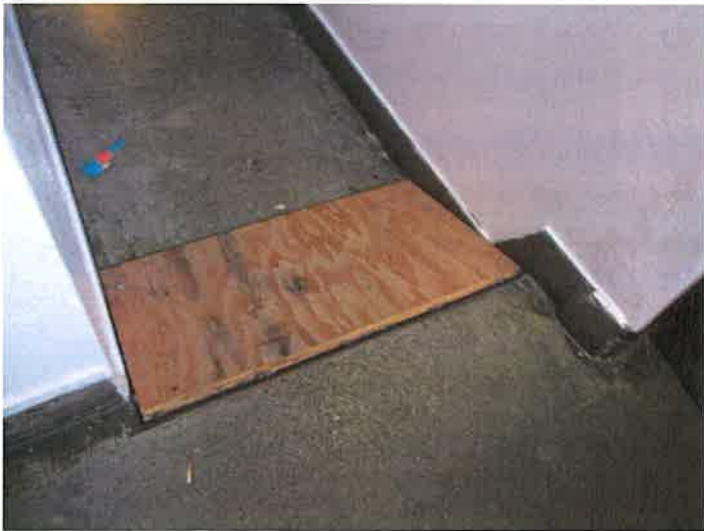
Makeshift wooden ramp into the locker rooms is not ADA compliant

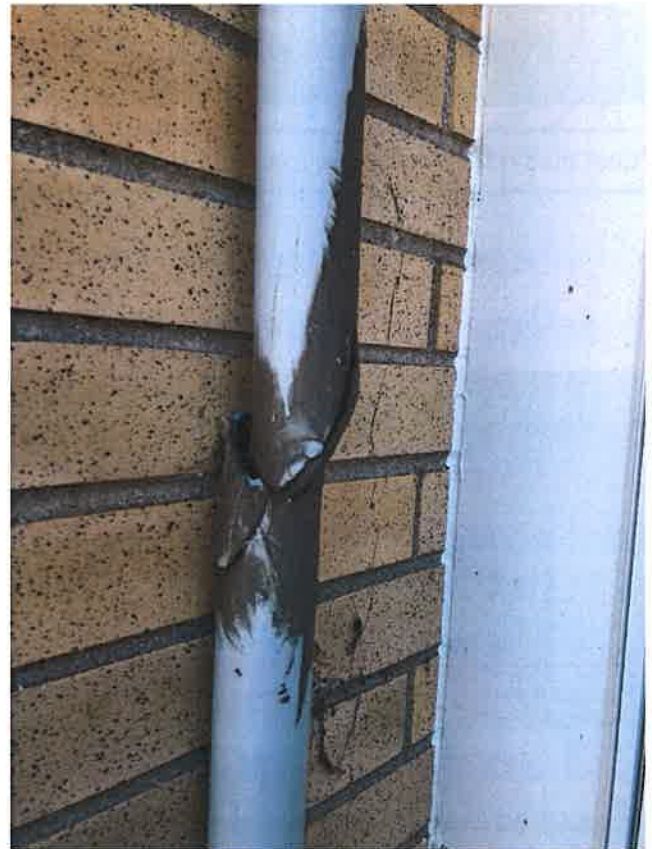
Downspouts are damaged

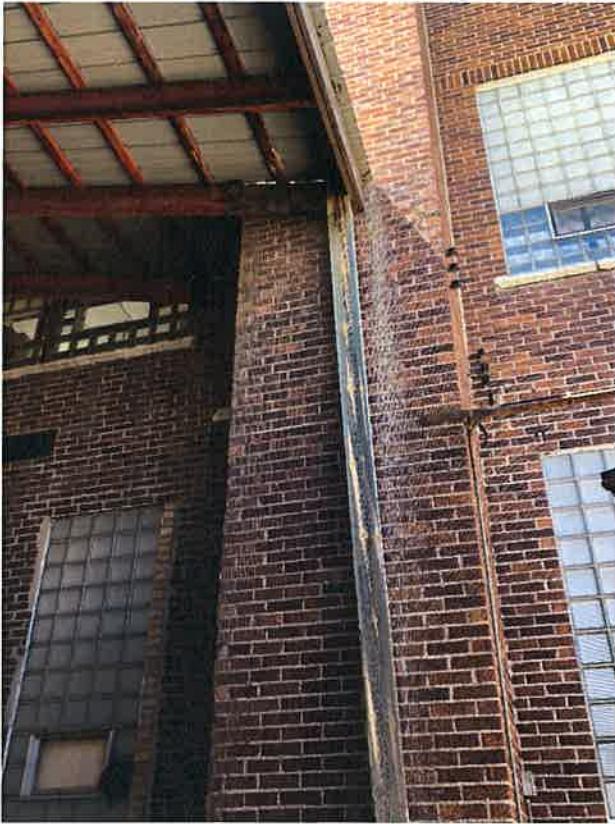
Coal shed is in poor/unstable condition

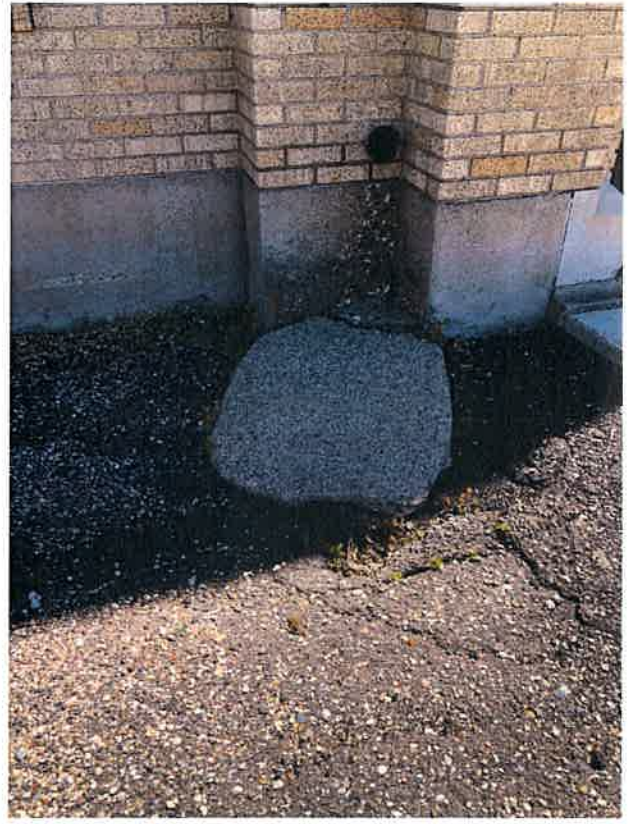
Drainage freezing and thawing damage throughout the site

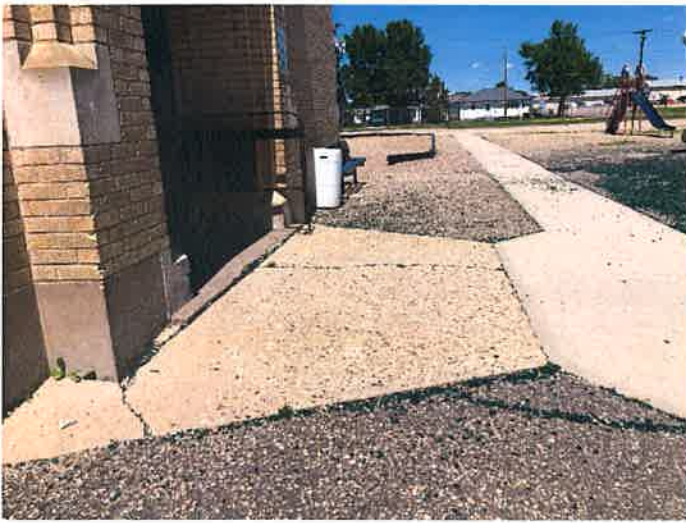
Sidewalk and brick deterioration

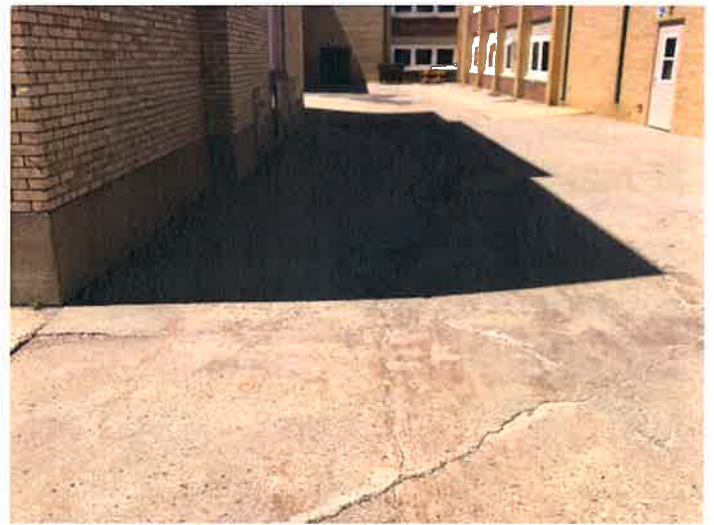
Back courtyard between the building additions is sinking and causing storm sewer collapse
